# Auckland Affordable Inspect a Home

**Visual Residential Property Inspection  
of SAMPLE PROPERTY**

in Accordance with NZS 4306:2005

**Site Address:** SAMPLE REPORT

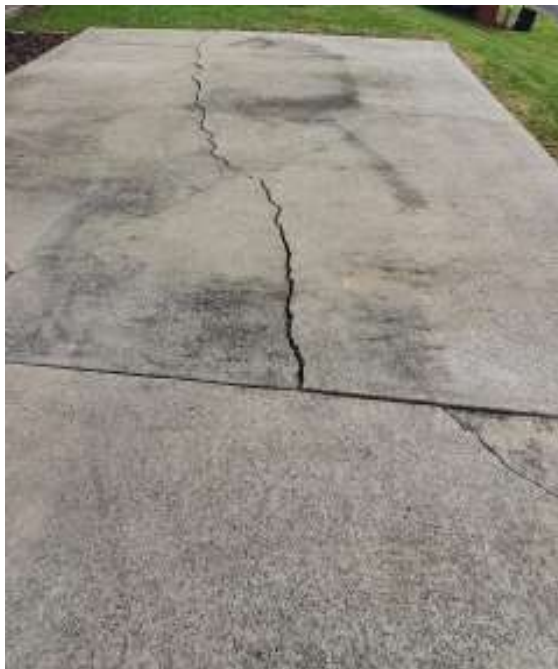
Cracks to concrete paving. It is recommended that It is sealed.

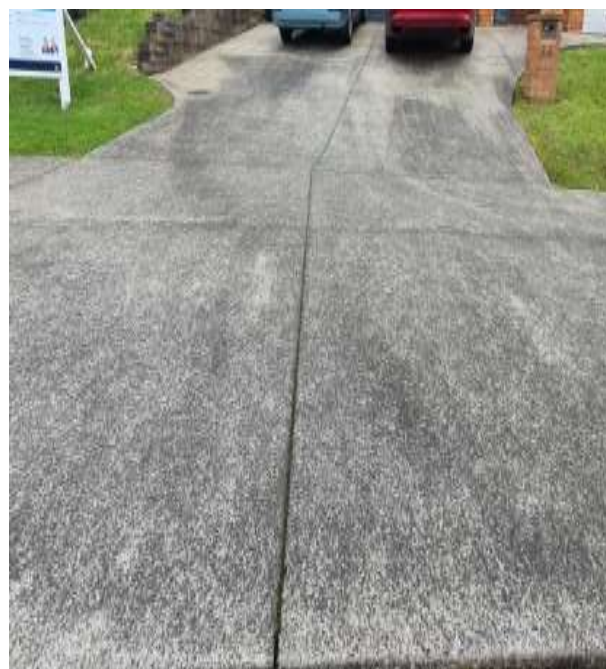
Concrete Driveway in good condition

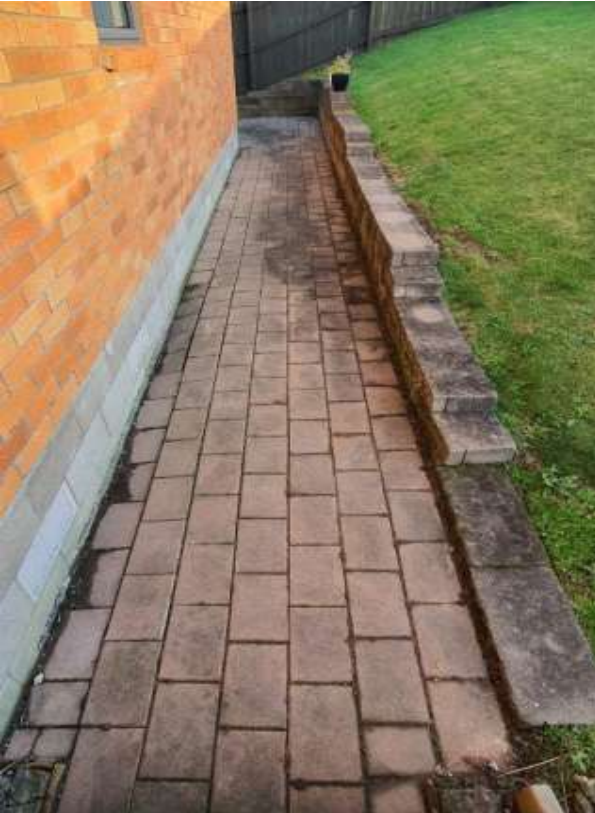
Brick paving subsiding due to poor compaction. Brick paving at plinth must be lifted, compacted and relayed so that the water does not run into the foundations

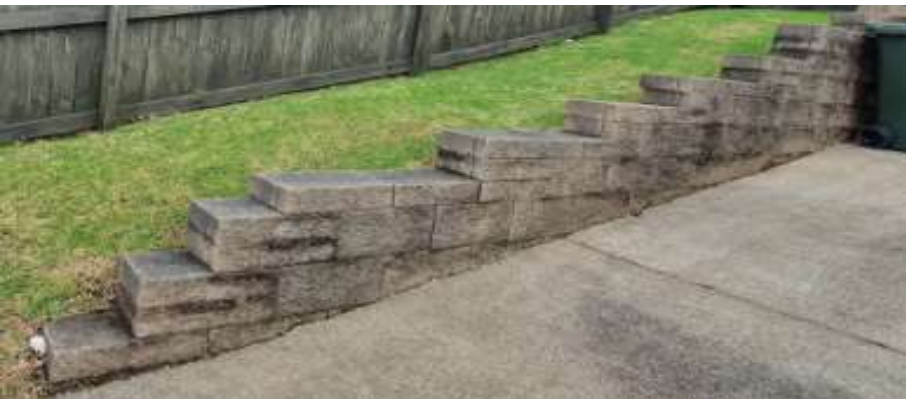
Concrete Block Retaining Wall in good condition

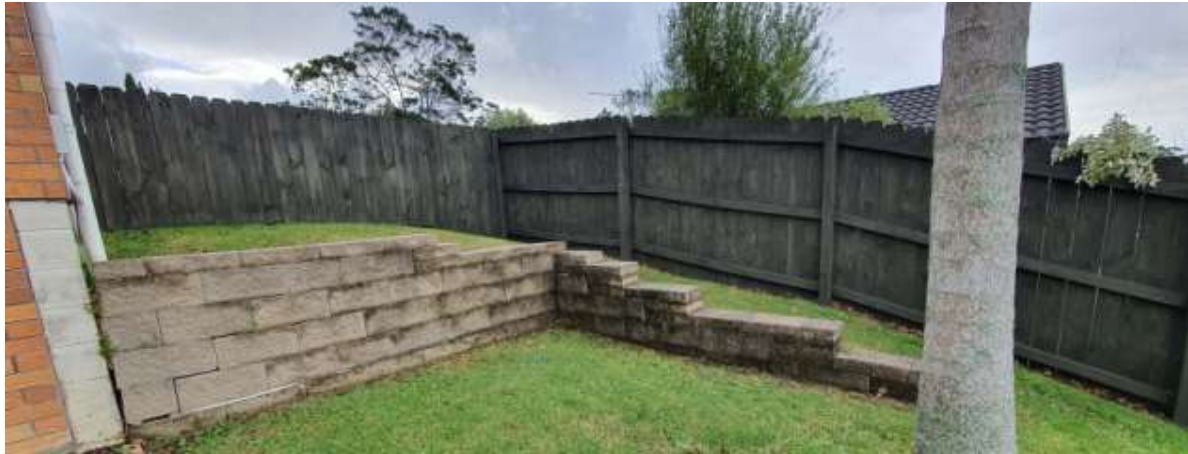
Concrete Block Retaining Wall in good condition. 1.8 m high slatted timber fence in good condition

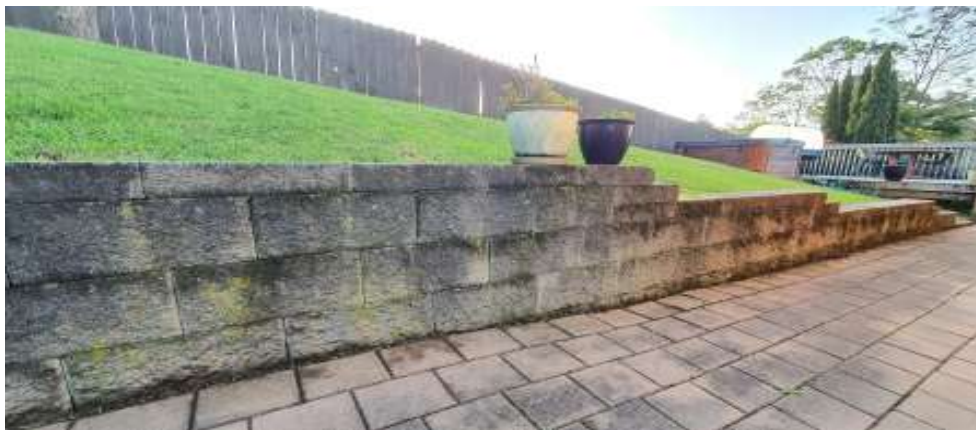
Concrete Block Retaining Wall in good condition. Brick paving in good condition

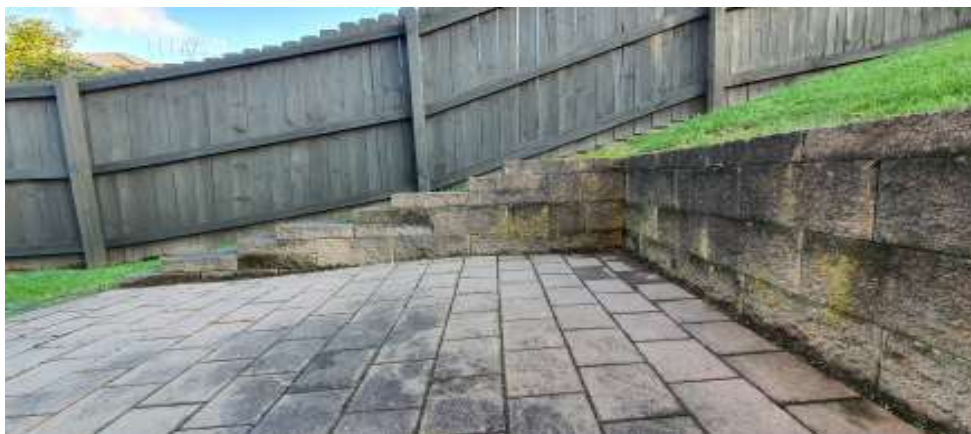
Brick paving in good condition. 1.8 m high slatted timber fence in good condition

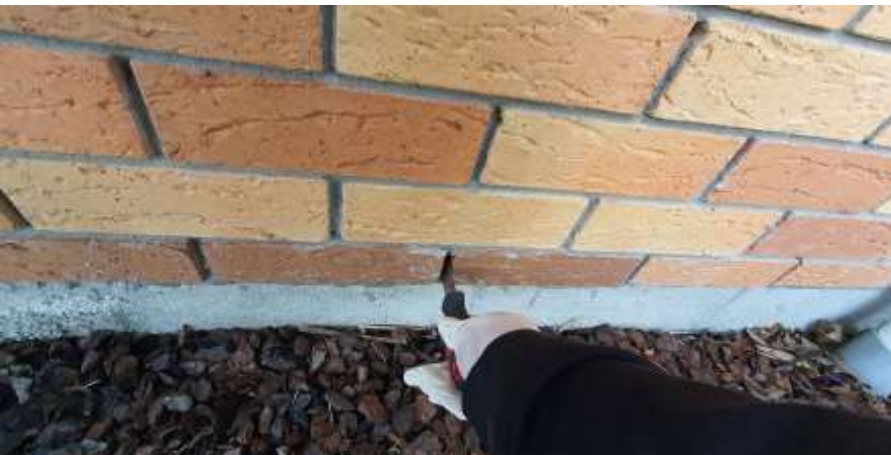
Weep hole clean. Many weep holes have been closed at construction time. They need to be opened to allow the cavities to vent and for water to exist the cavity.

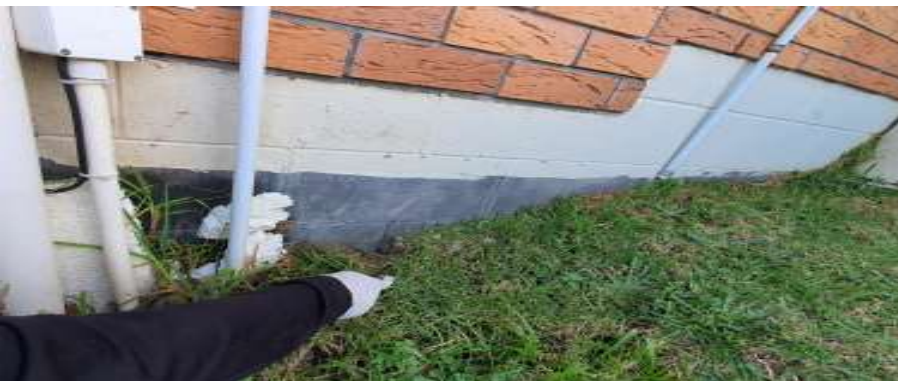
Waterproofing to foundation walls acceptable

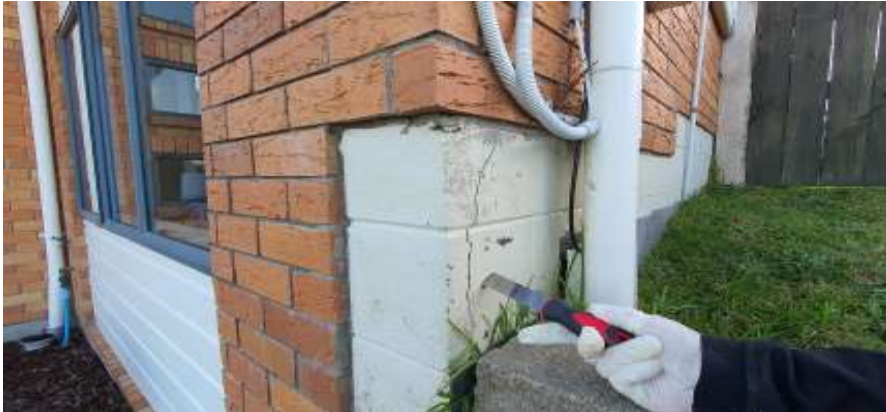
Fine crack to concrete block plinth. The crack is however not carrying on to the Brickwork. One should watch the crack. If it gets large, then I recommend that you Should seek the advice of a Structural Engineer.

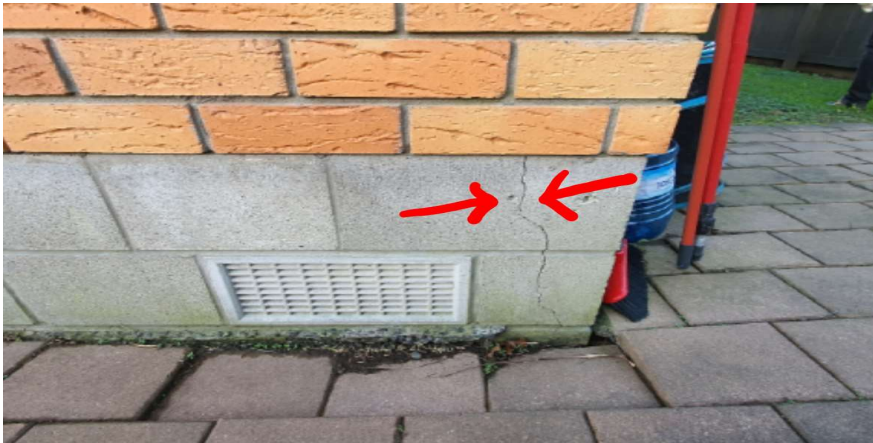
Fine crack to concrete block plinth. The crack is however not carrying on to the Brickwork. One should watch the crack. If it gets large, then I recommend that you Should seek the advice of a Structural Engineer. The brick paving should be lifted, compacted and re-laid. Water must be kept away from the foundations

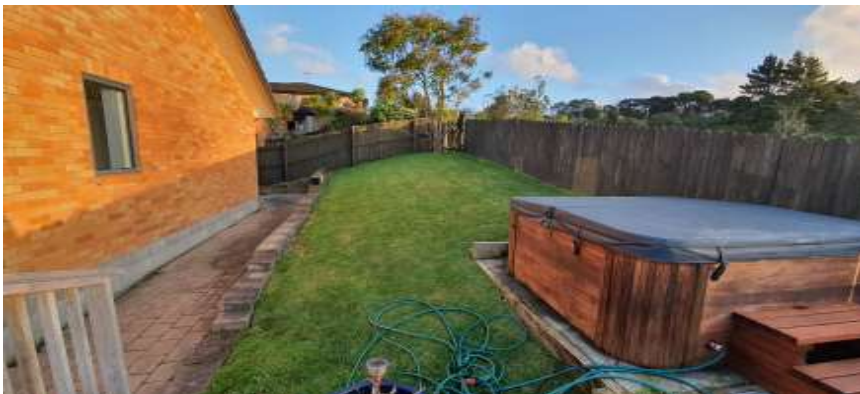
The brick paving should be lifted, compacted and re-laid. Water must be kept away from the foundations

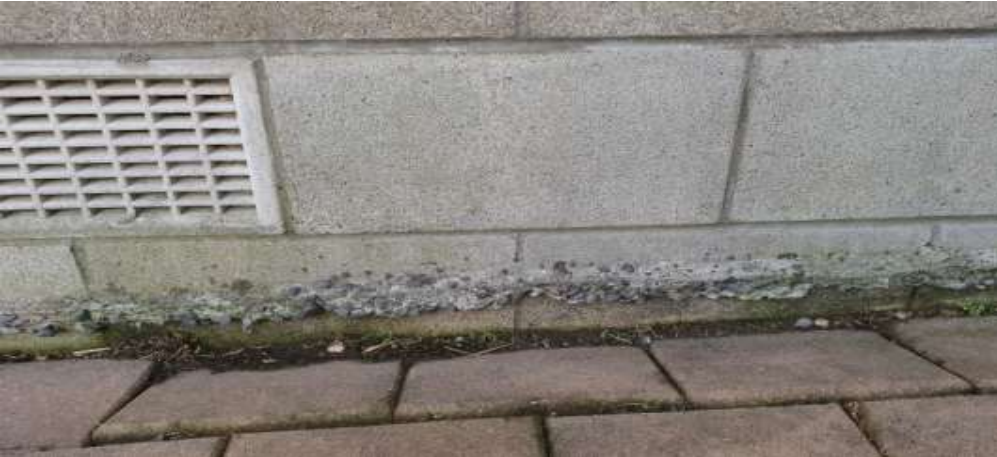
The brick paving should be lifted, compacted and re-laid. Water must be kept away from the foundations

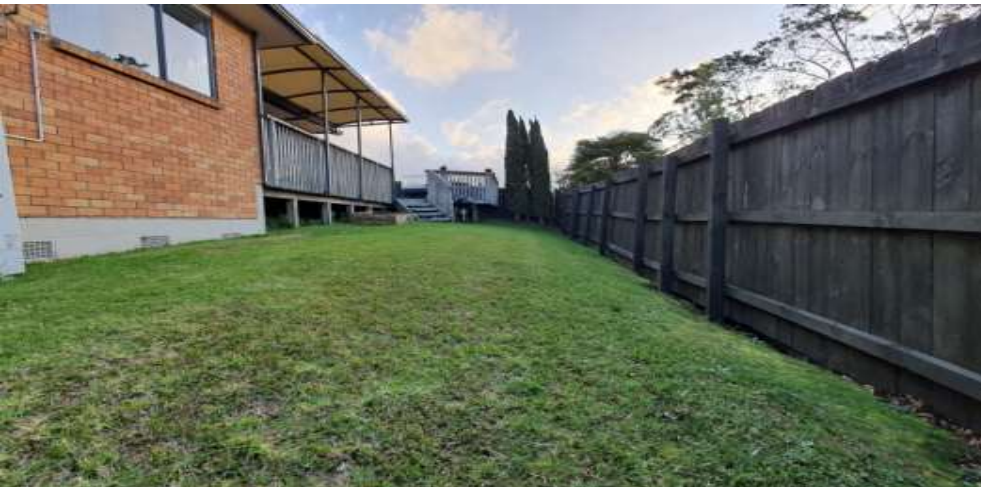
Well maintained lawns sloping away from foundations.

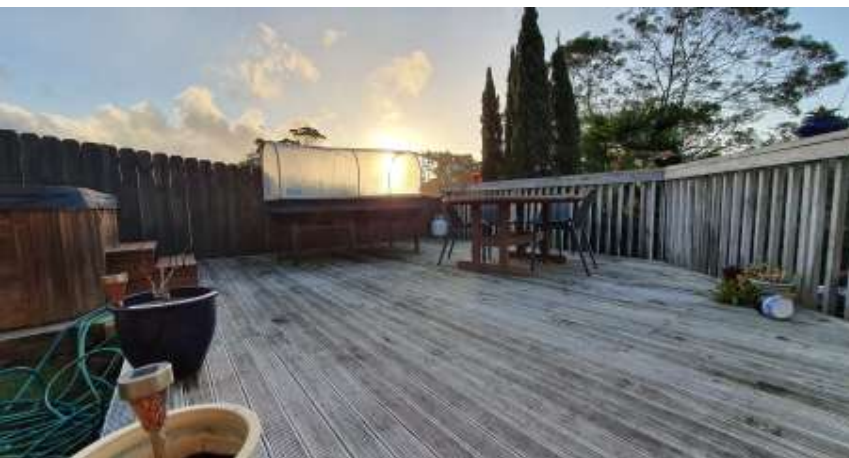
Timber decks in good condition for their age

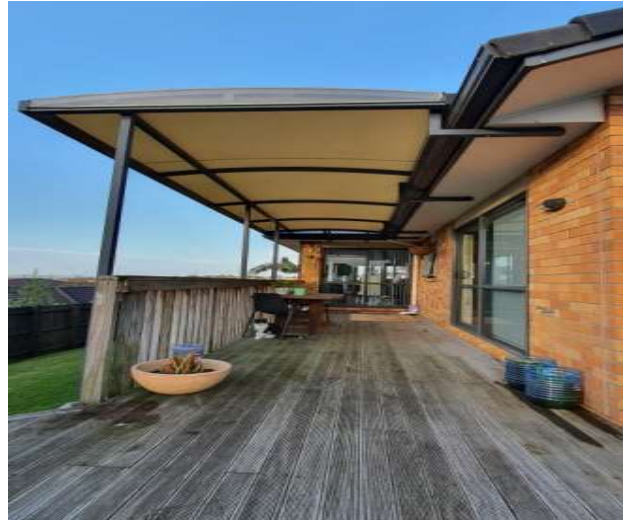
Awning to lounge and main bedroom in good condition

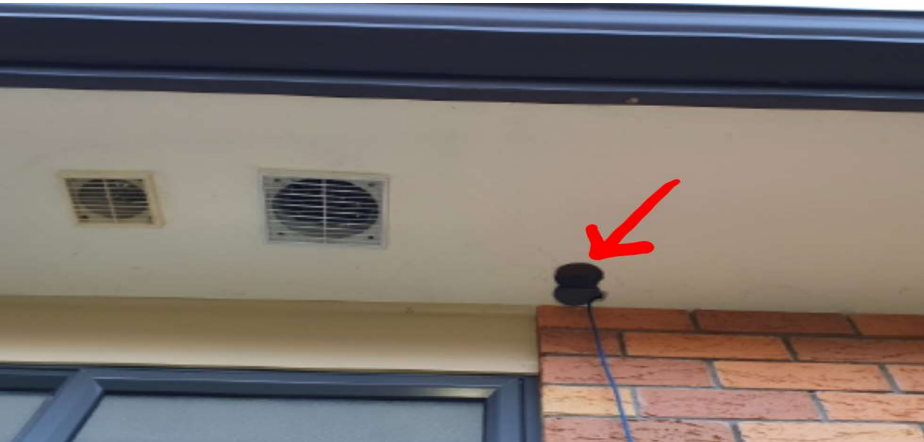
Hole to soffit should be closed

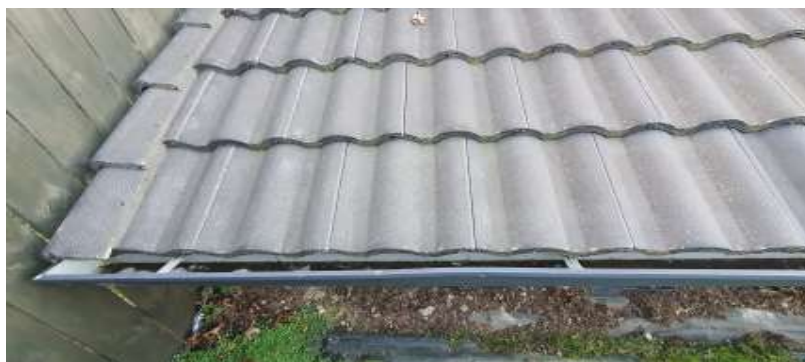
Still water in the spouting

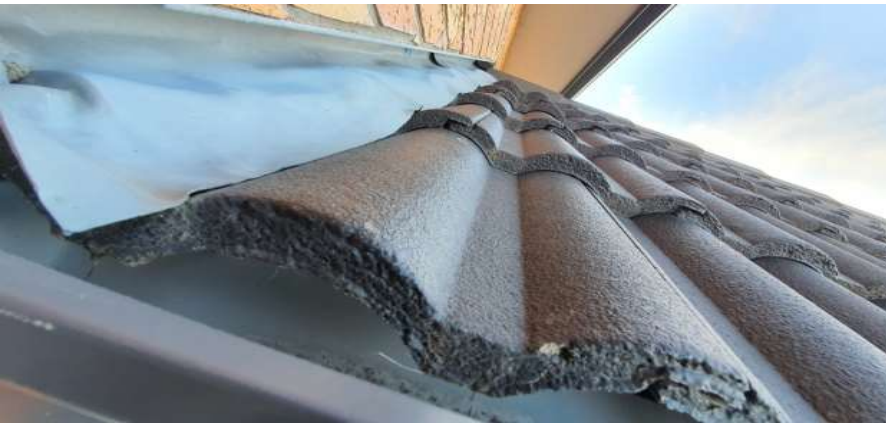
Lead flashing to brick veneer acceptable

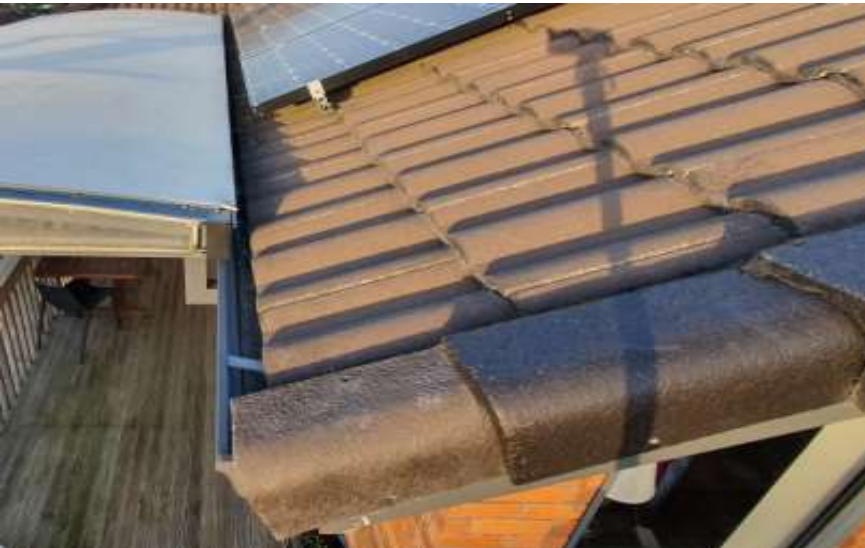
Concrete roof tiles in good condition Spouting clear

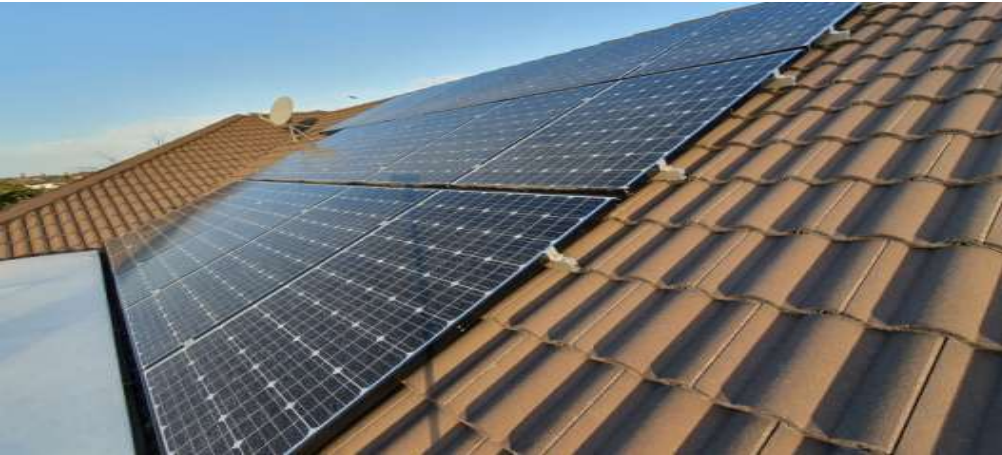
Solar panels securely fixed to roof

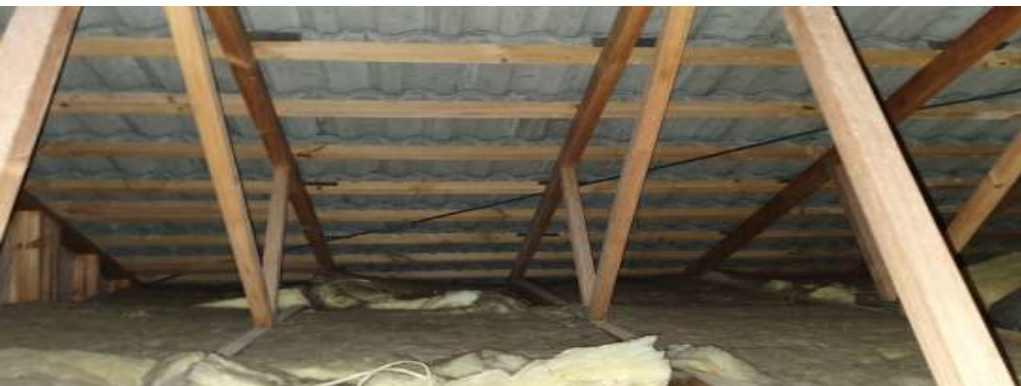
Insulation to roof space acceptable. Pre nailed roof truss good condition. No underlay to concrete roof tiles acceptable

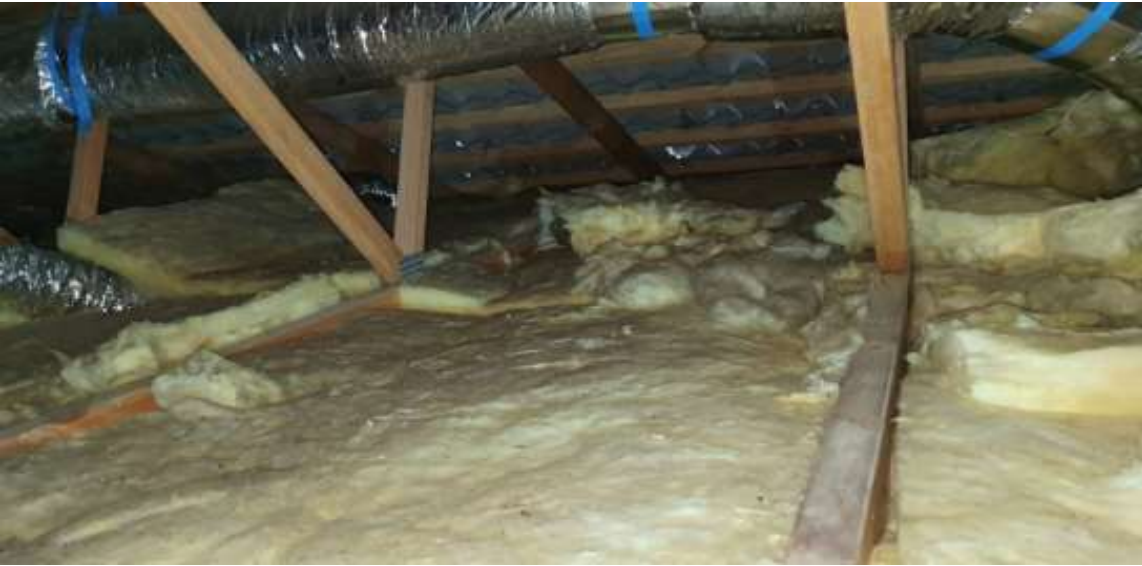
Insulation to roof space acceptable

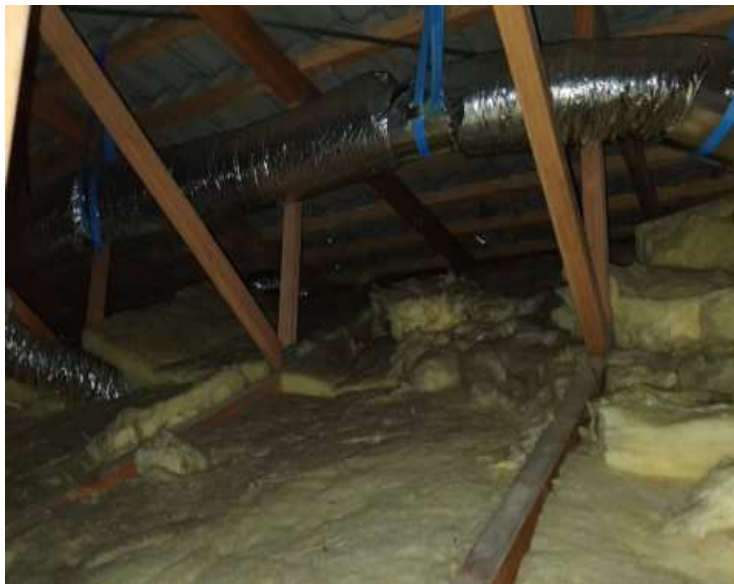
Insulation to roof space acceptable. Pre nailed roof truss good condition.

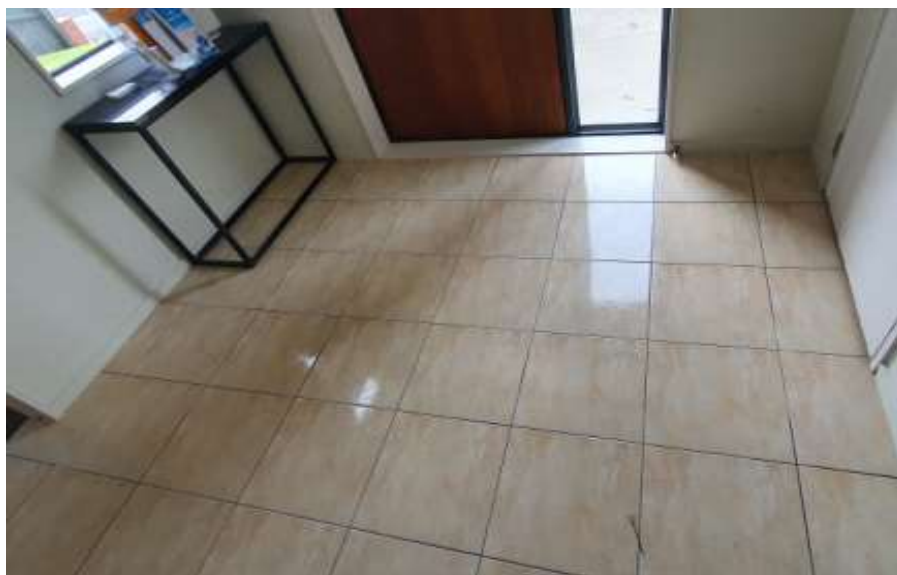
Tiled entrance hall in good condition

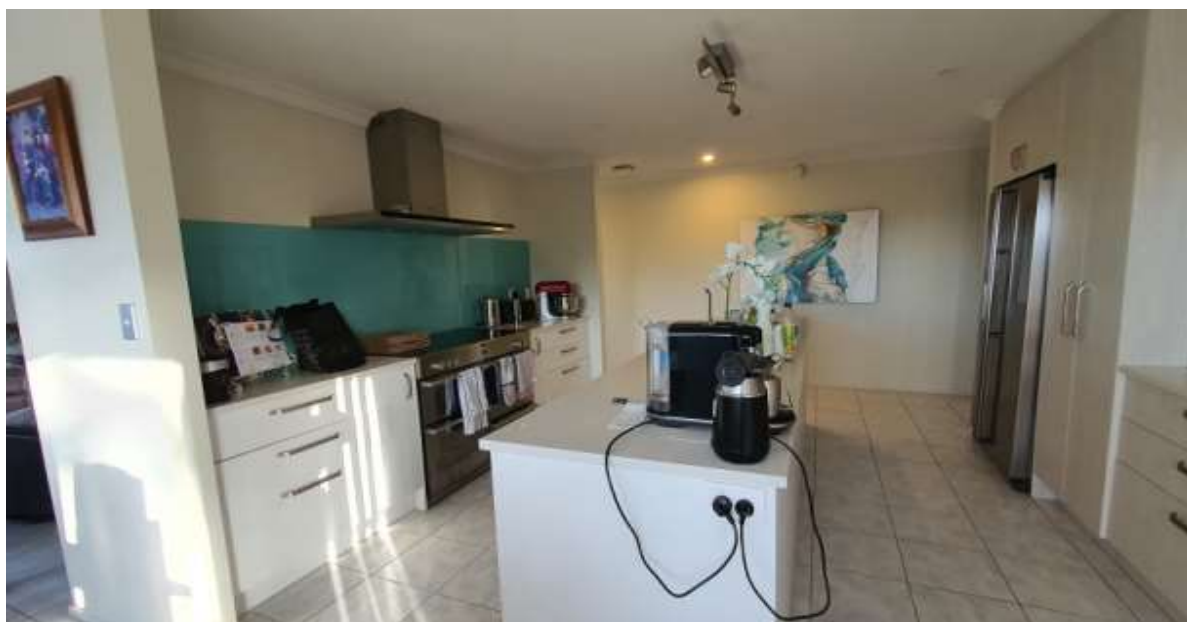
Modern kitchen. Cupboard doors and drawers in good working order.

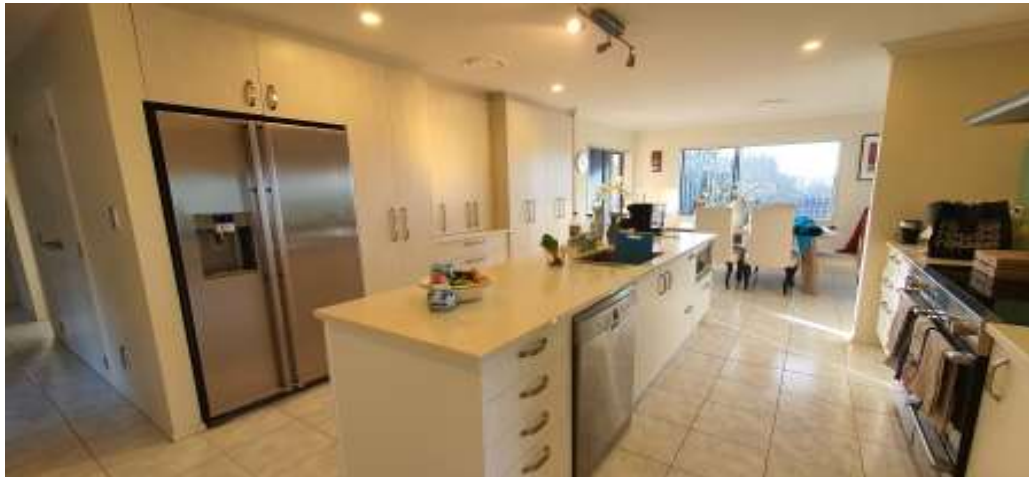
Floor tiles in good condition

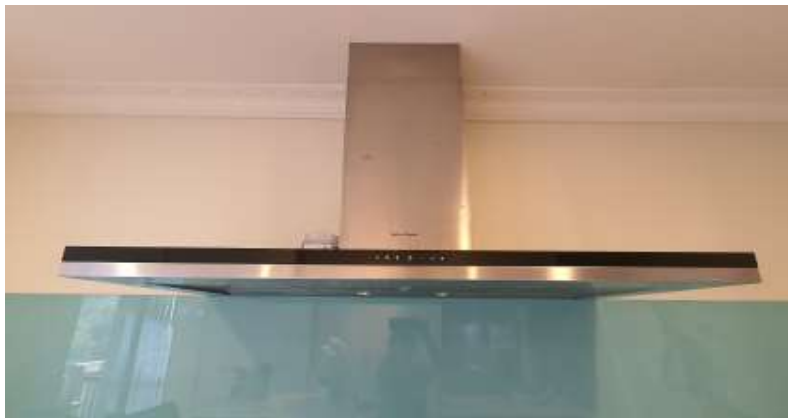
Range hood working fine

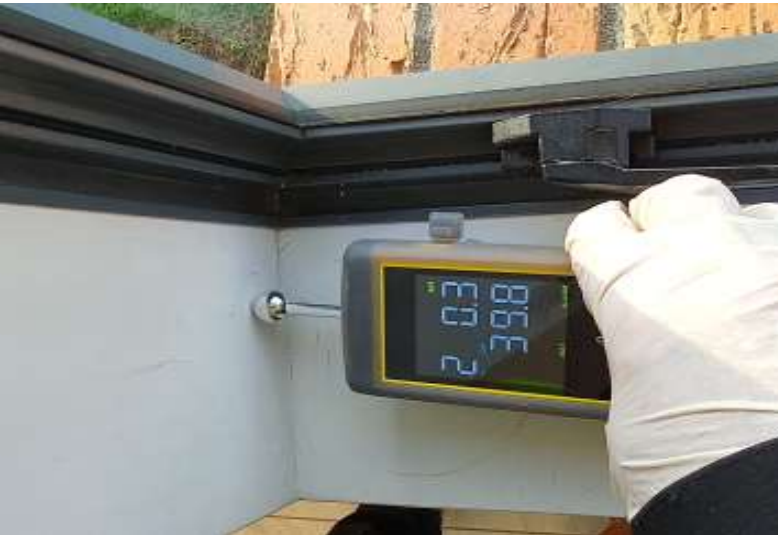
Moisture reading acceptable

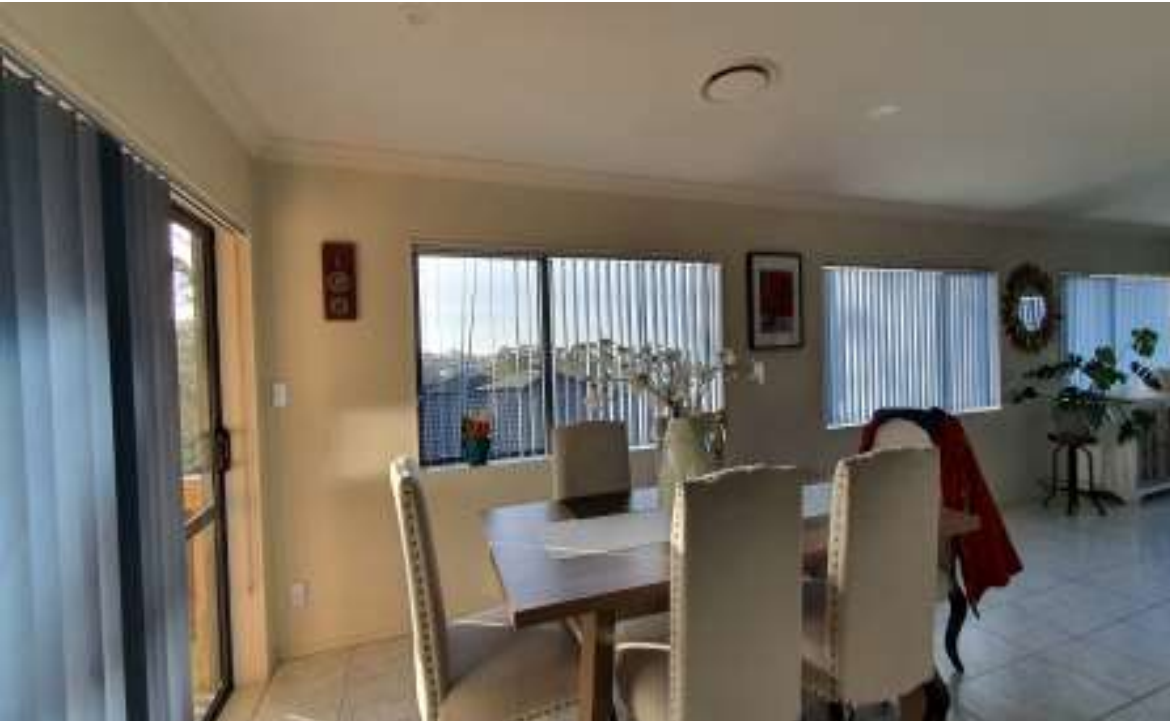
HRV to dining room. Vertical bricks throughout the house in good condition

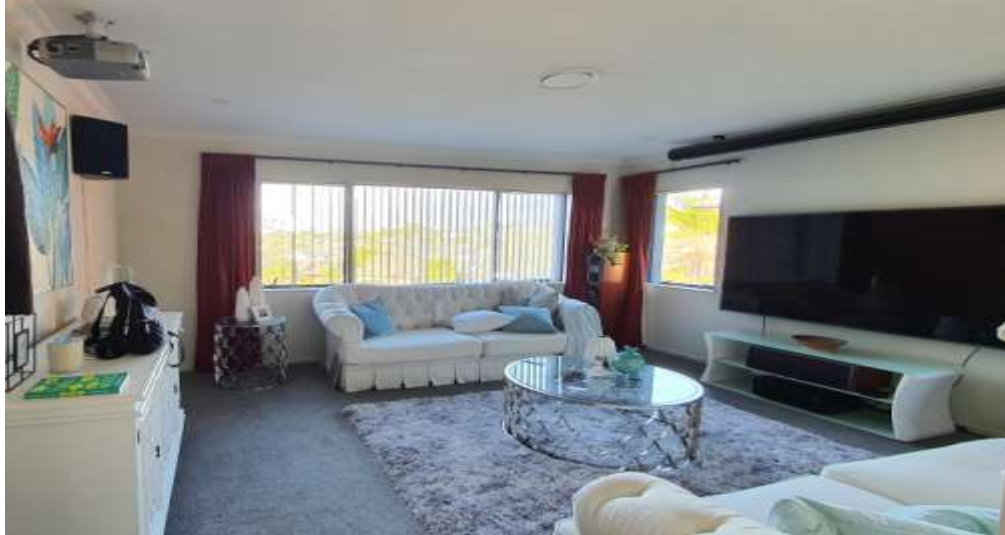
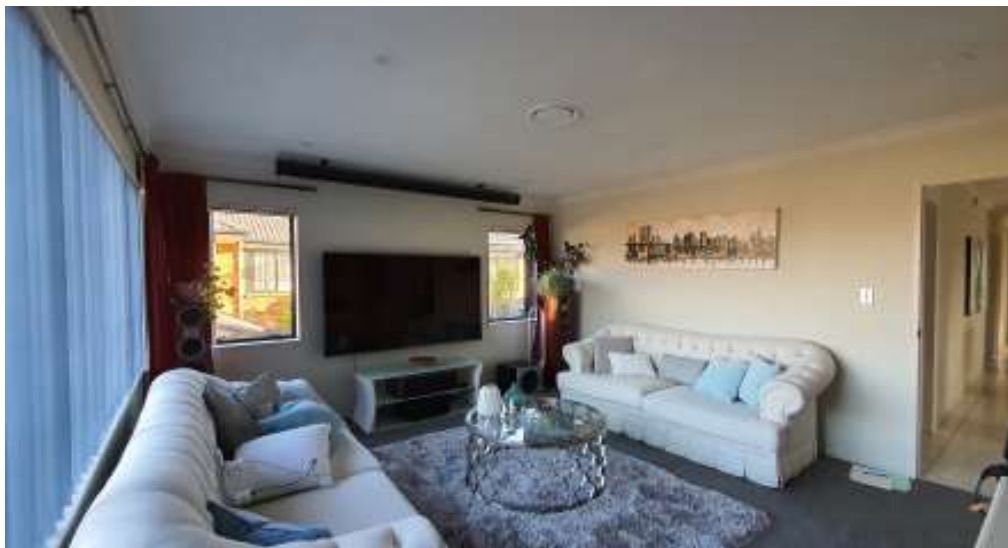
HRV to Family room. Vertical bricks throughout the house in good condition

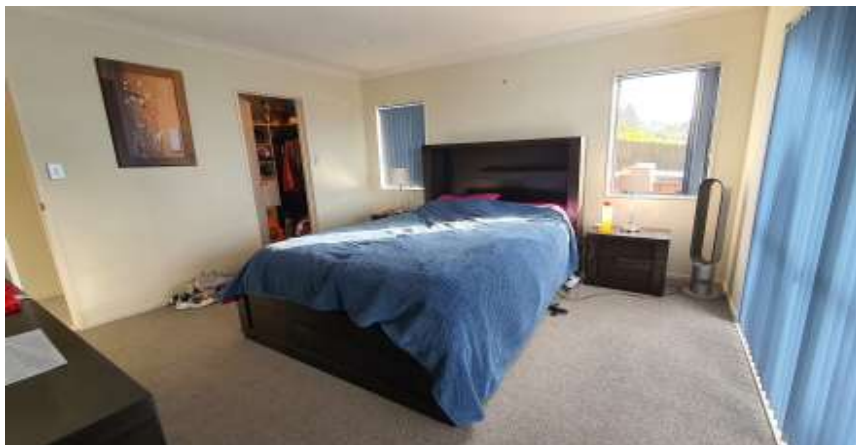
Master bedroom door catching carpet

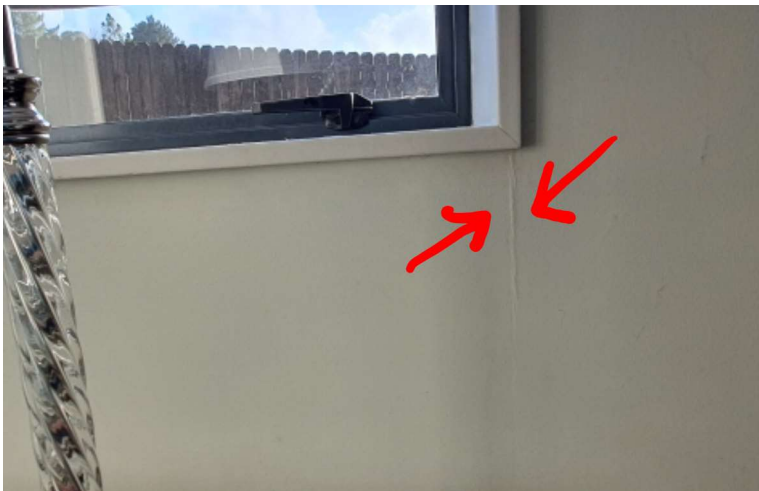
Crack in the wall under the window

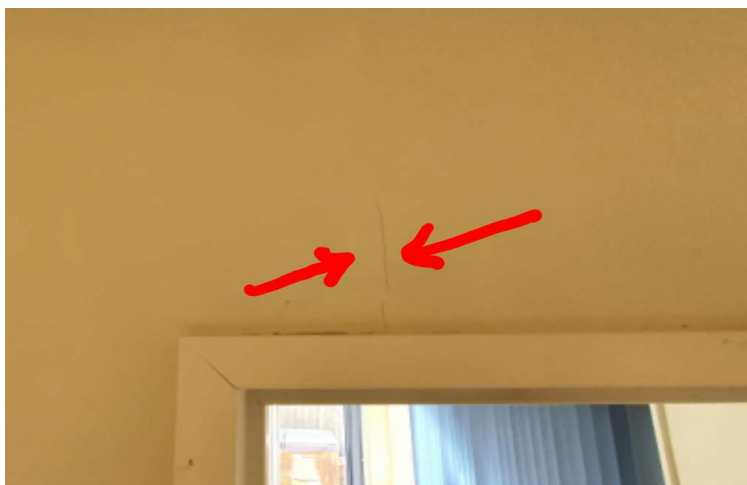
Crack to gib lining above the bathroom door

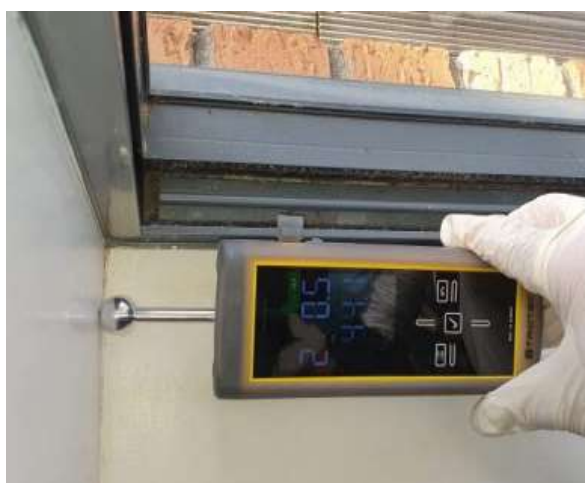
44.1 Moisture meter reading acceptable

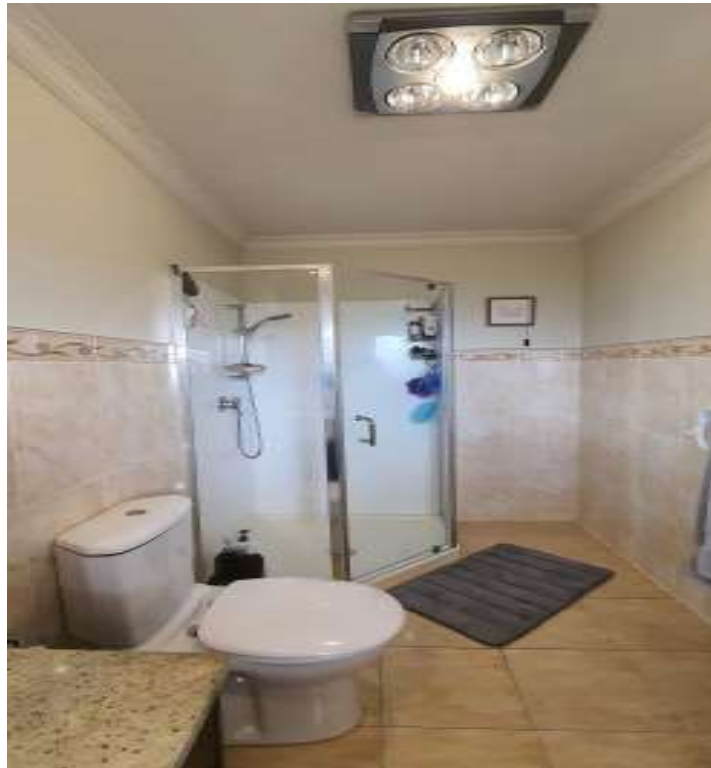
Toilet seat loose.

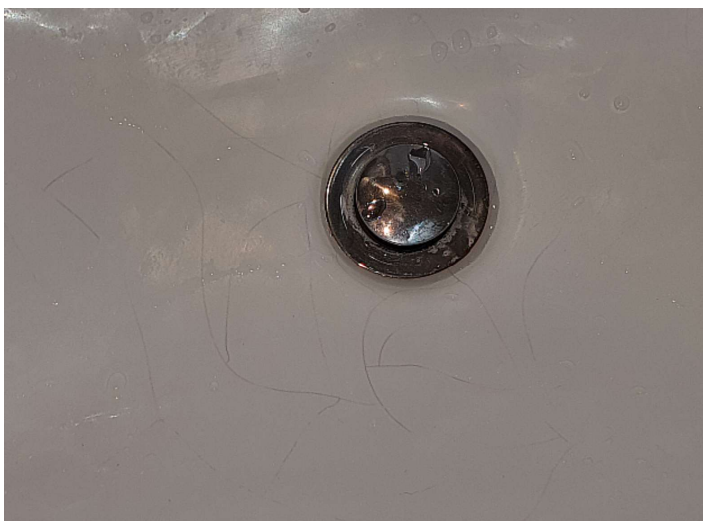
There is lots of fine crack in the washbasin

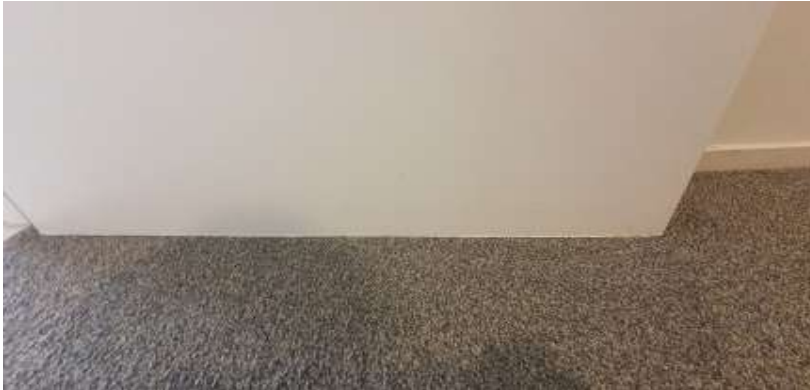
The bedroom door catching carpet

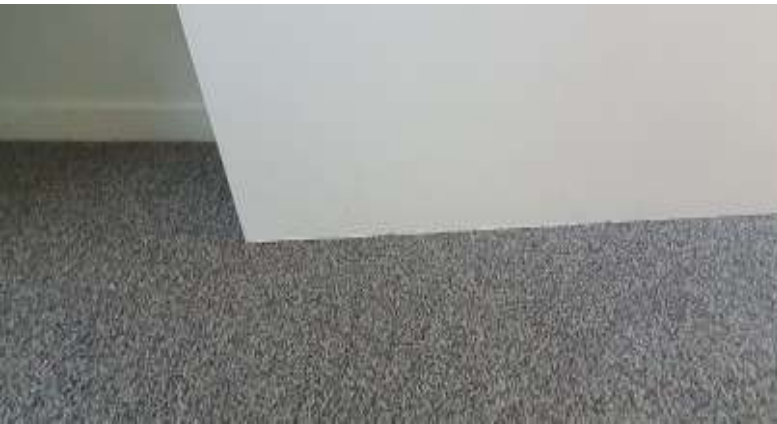
The bedroom door catching carpet

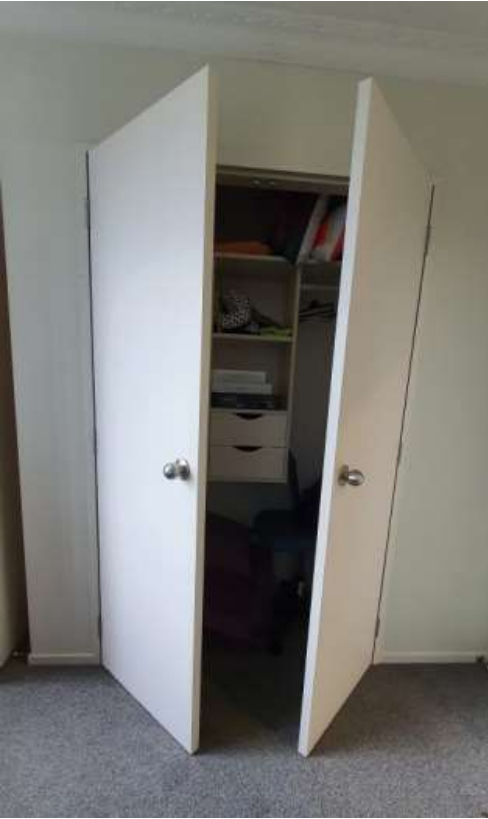
Wardrobe doors acceptable

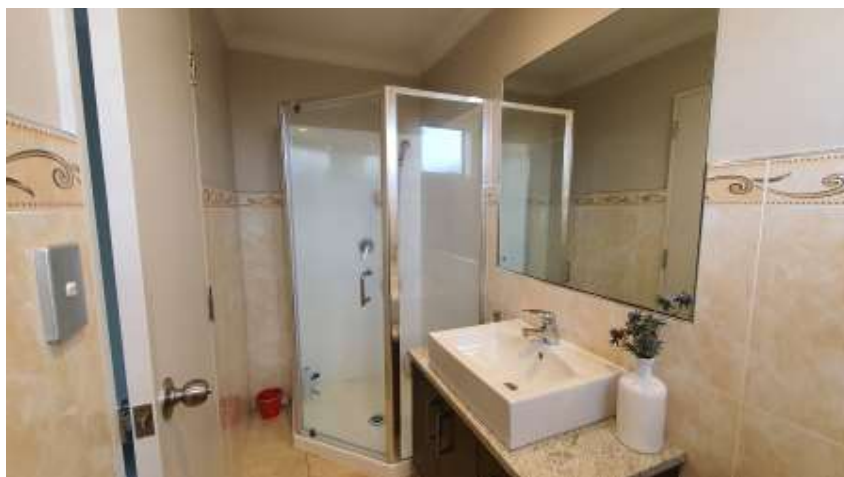
No leaks to shower cubicle

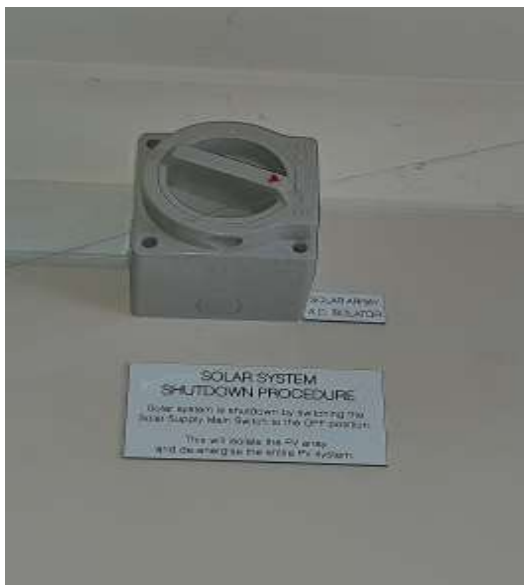
Solar system shut down switch

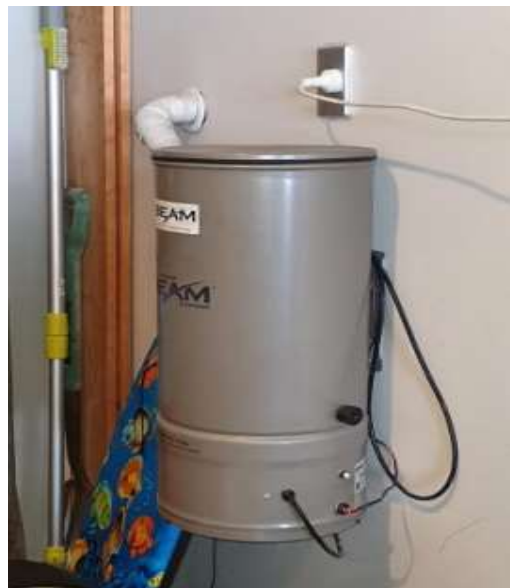
Vacuum system has not vacuum pipe

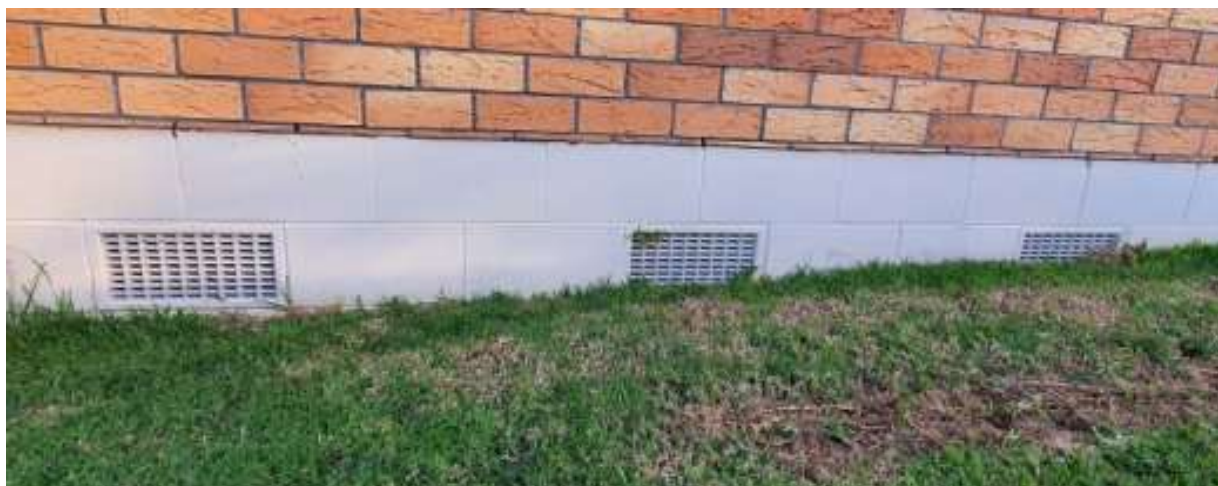
Well ventilated sub floor

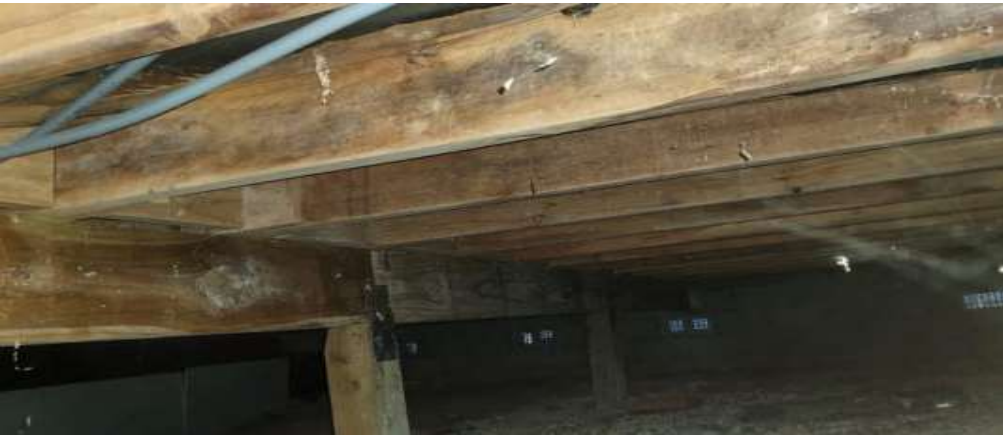
Timber to subfloor in good condition. Subfloor dry

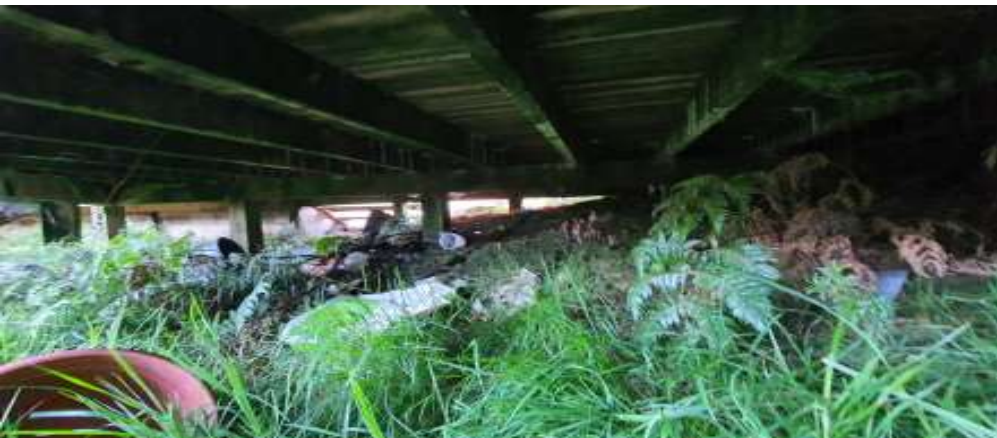
Underside of timber deck acceptable. Weeds should be removed

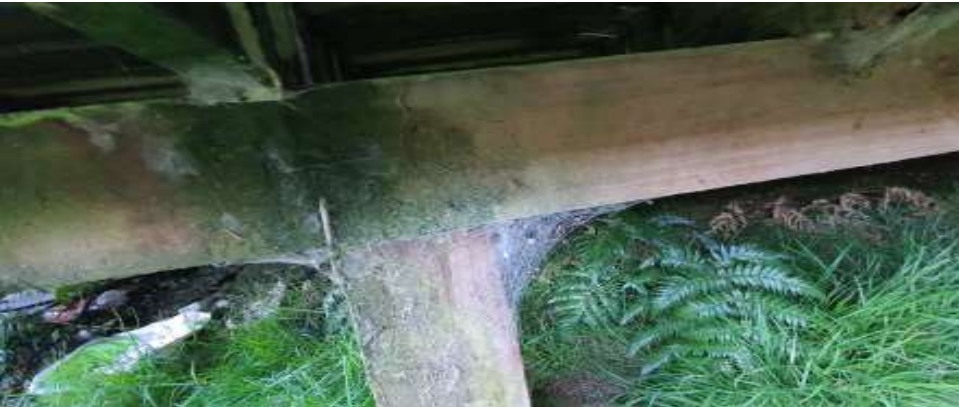
Timber members in fair condition for its age

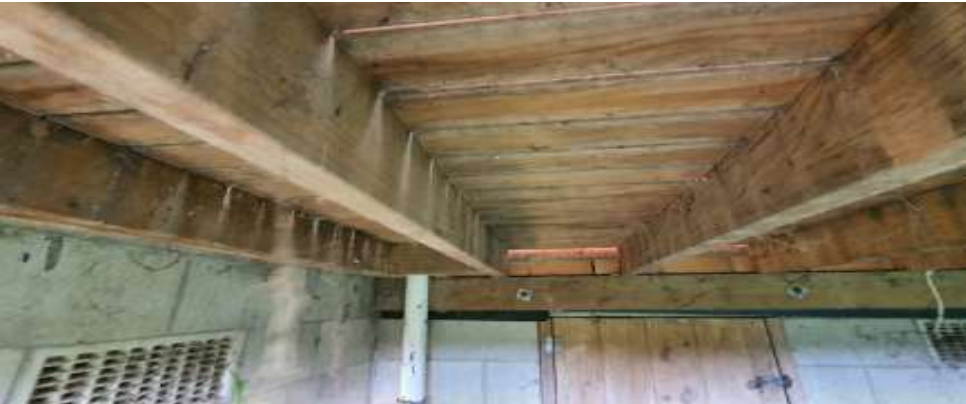
Timber members in fair condition for its age

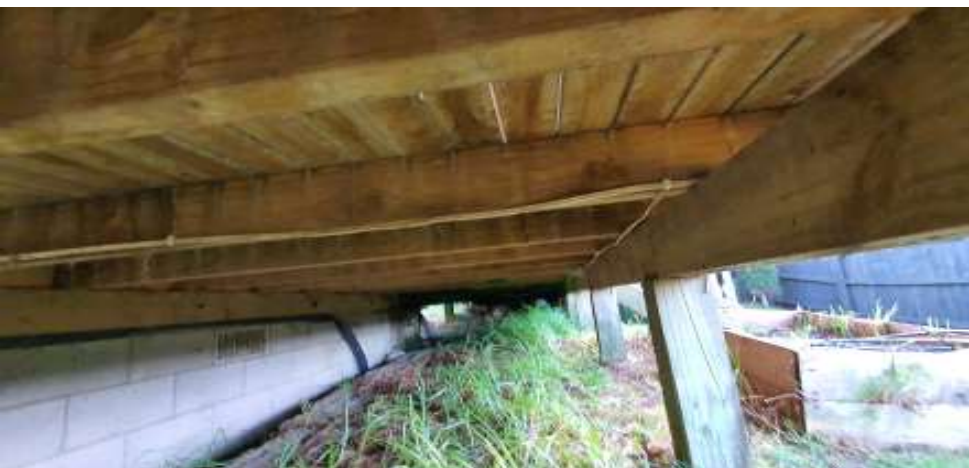
Underside of timber deck acceptable. Weeds should be removed

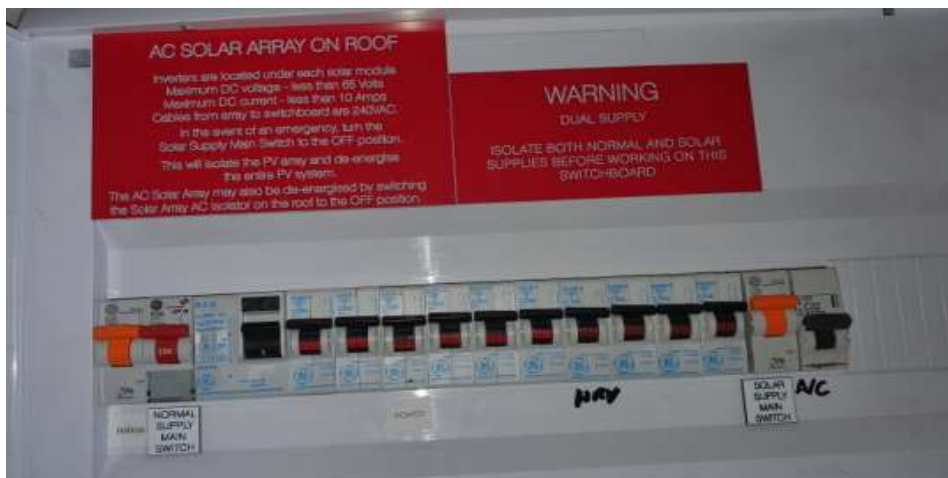
The DB board is not labelled
