# Auckland Affordable Inspect a Home

**Visual Residential Property Inspection  
of SAMPLE PROPERTY**

in Accordance with NZS 4306:2005

**Site Address:** SAMPLE REPORT

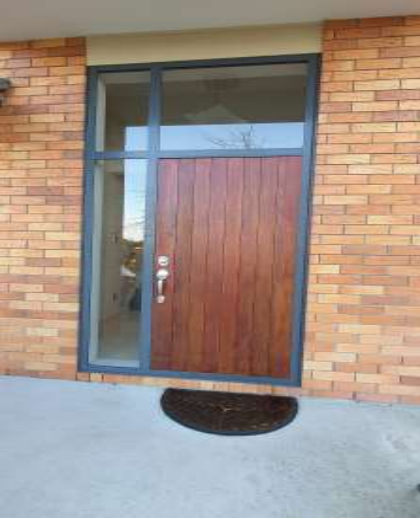
Timber Front door in good condition

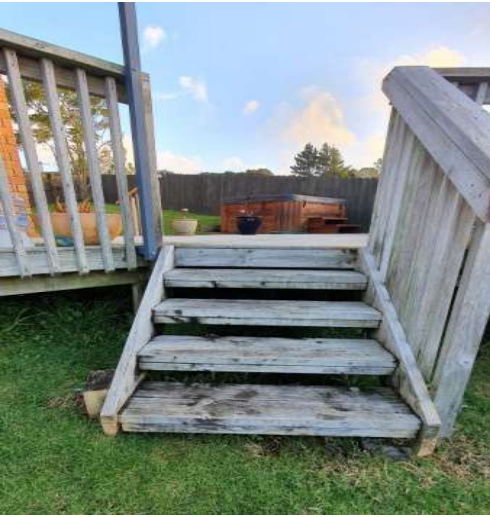
Timber steps to deck acceptable

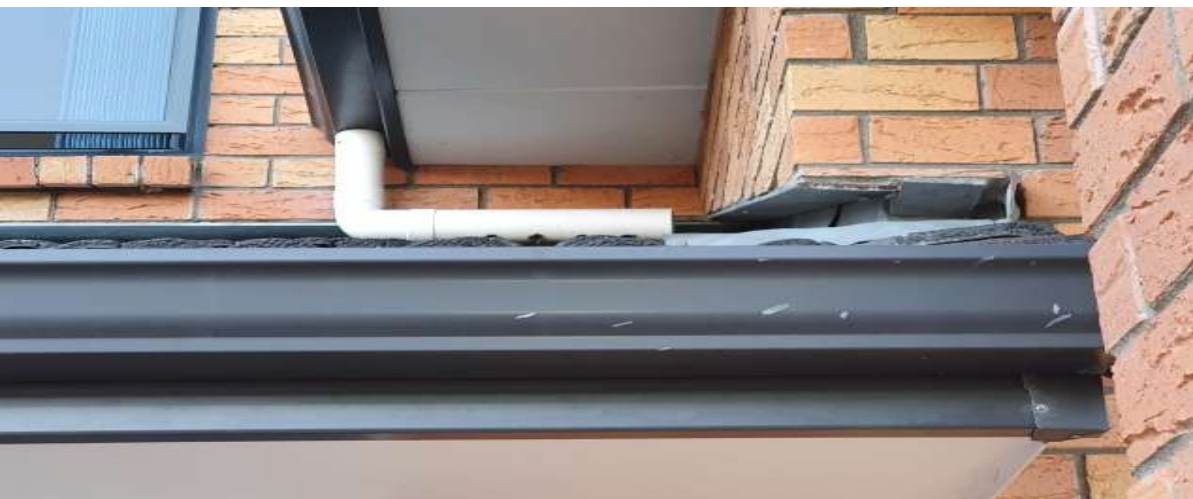
PVC spreader to the roof. Lead flashing finishes behind steel lintel

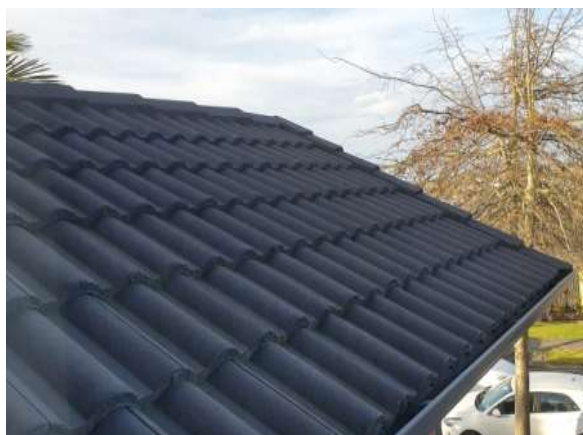
Tile roof in good condition

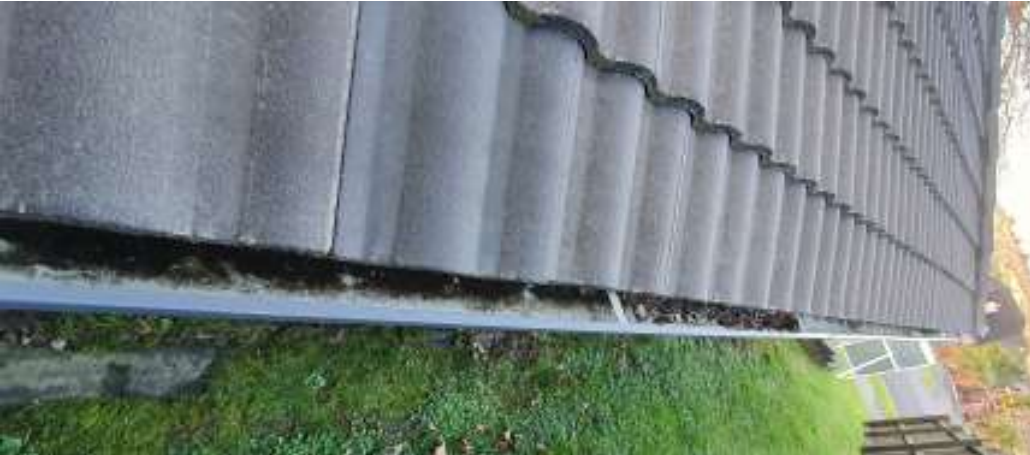
Spouting clear to most parts inspected, however as on the photo there is a little bit of still water in the spouting

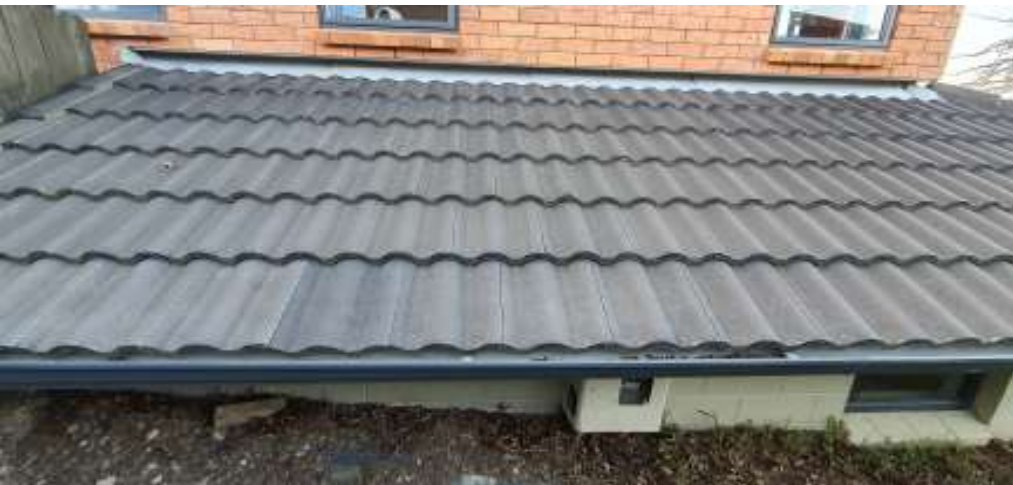
Spouting clear

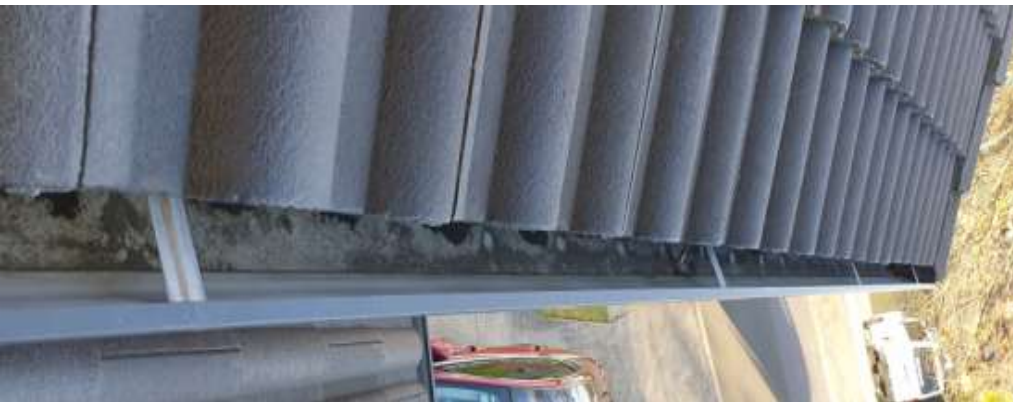
Spouting clear

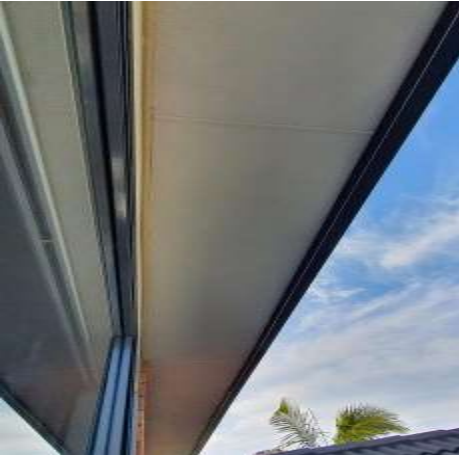
Wide eaves

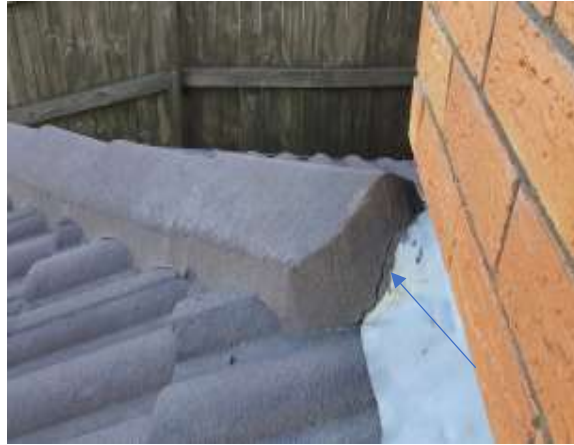
Crack to tile ridging needs to be sealed

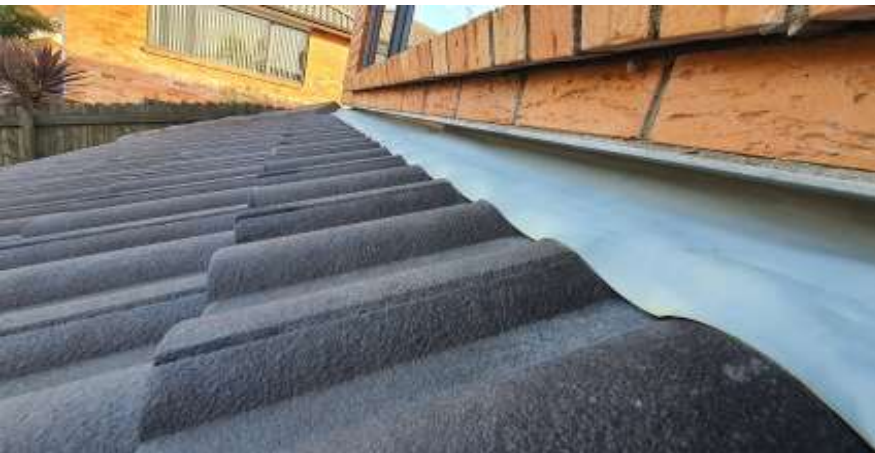
Lead flashing to brick veneer acceptable

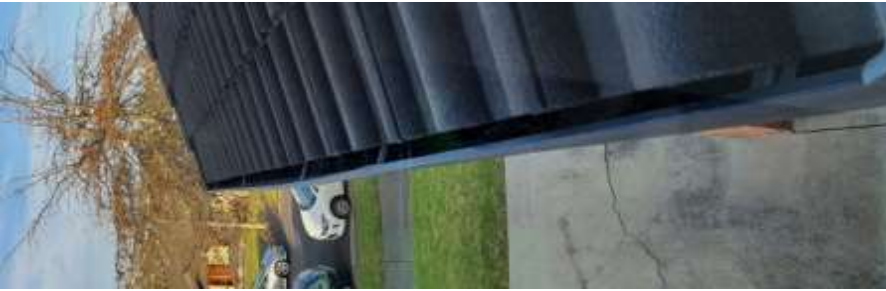
Spouting clear

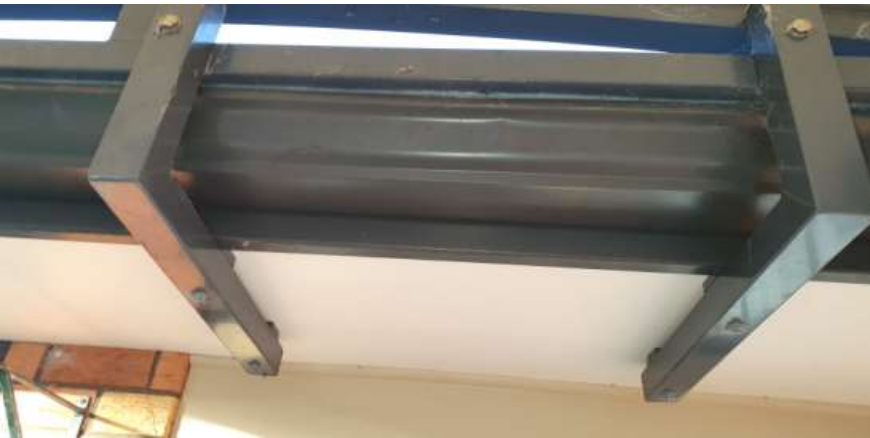
Pergola securely fixed to roof members

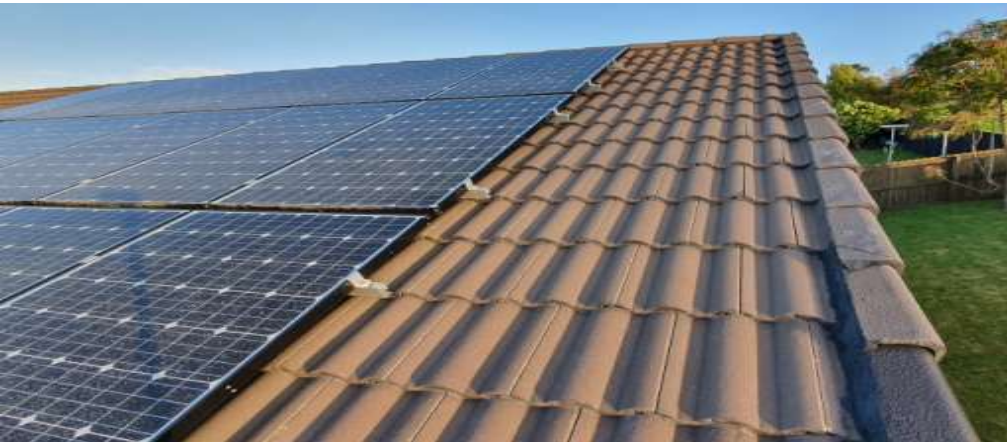
Solar panels securely fixed to roof

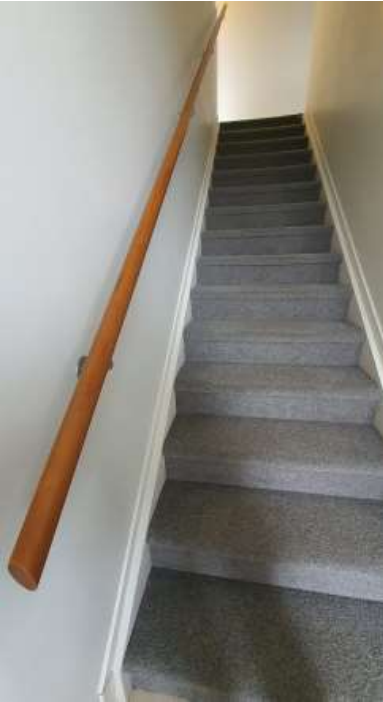
Handrail secure acceptable

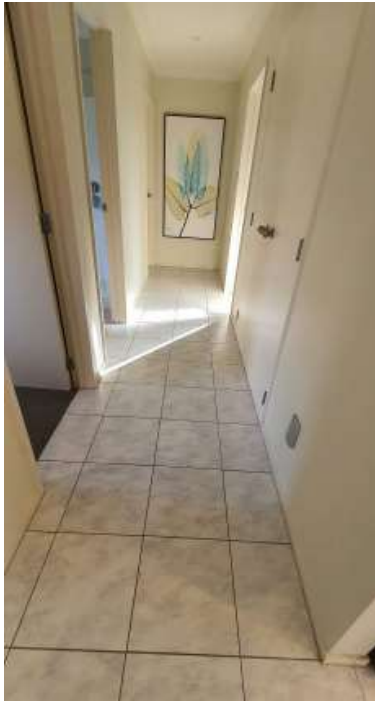
Upstairs passage and entrance hall floor tiles in good condition

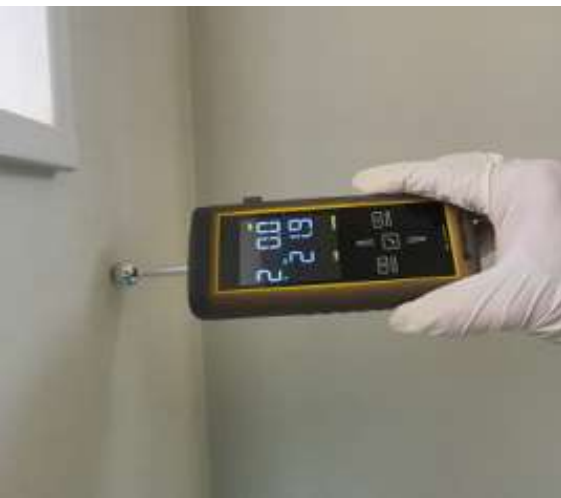
Moisture meter reading acceptable

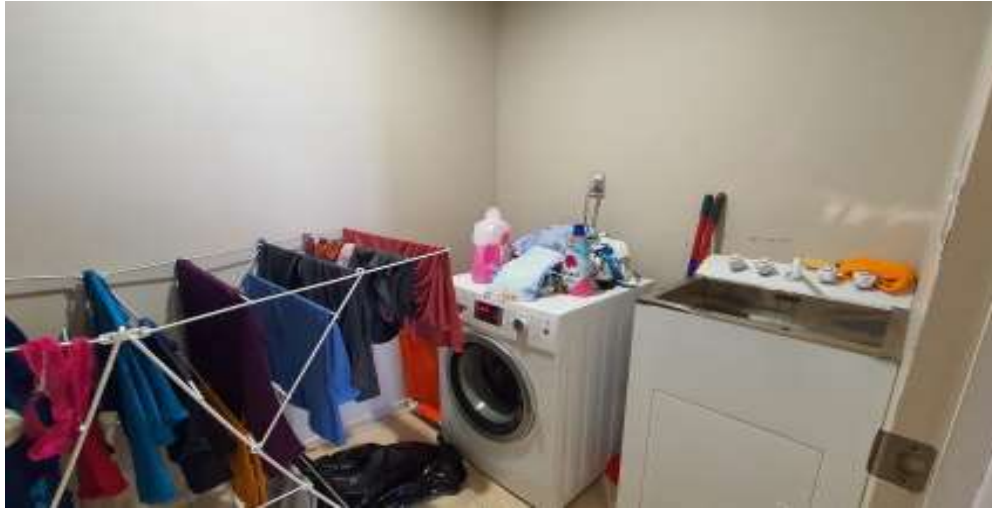
Water to wash trough tested

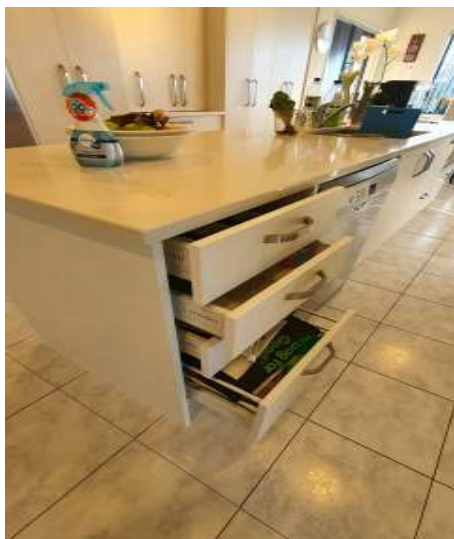
All of drawers are open smoothly.

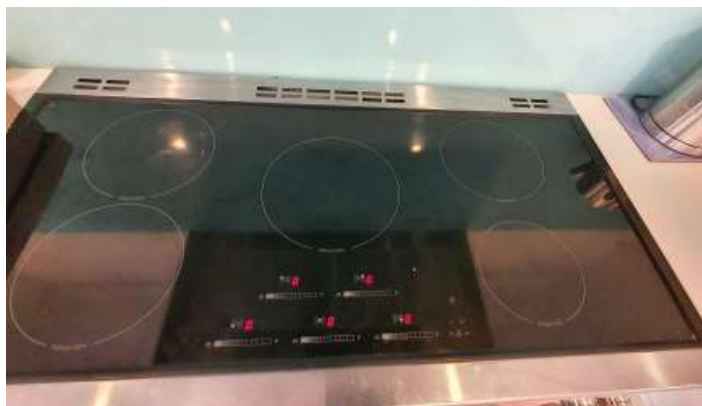
Induction hob working fine.

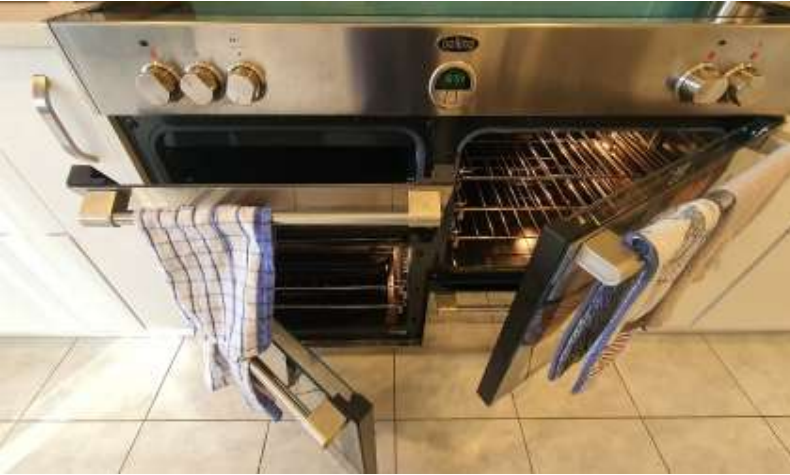
Oven working

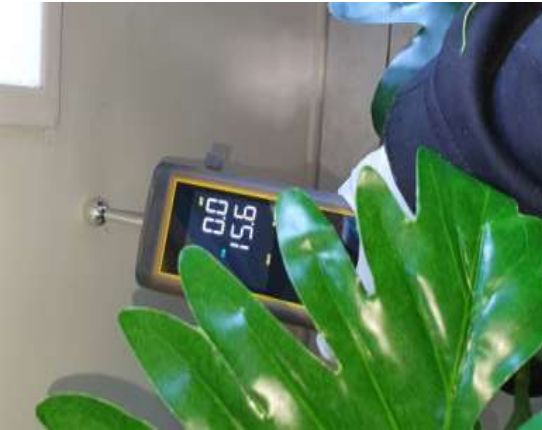
15.6 The moisture meter reading acceptable

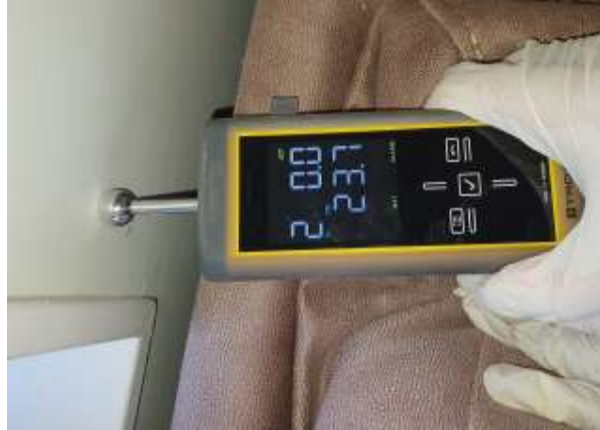
23.7 The moisture meter reading acceptable

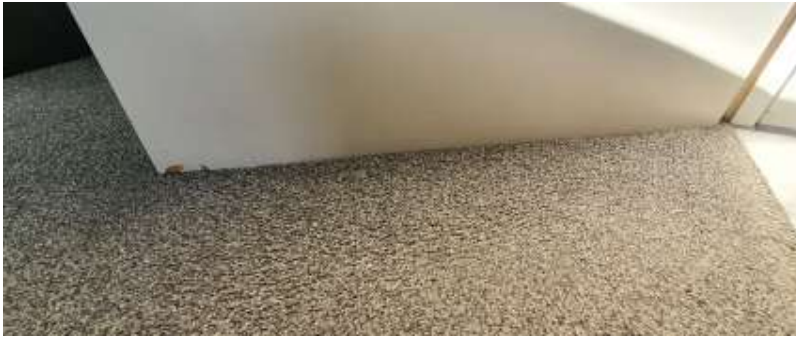
Master bedroom door catching carpet

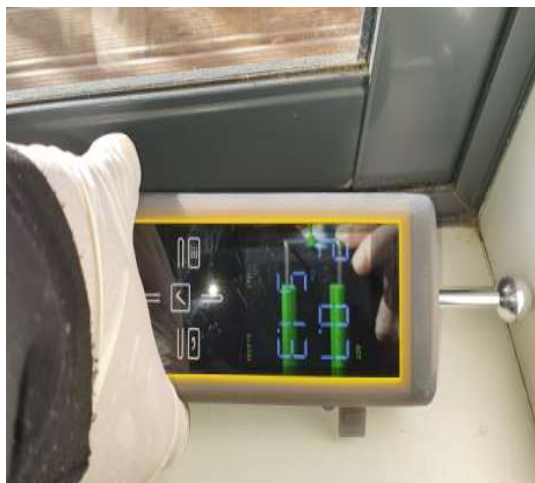
51.3 Moisture meter reading acceptable

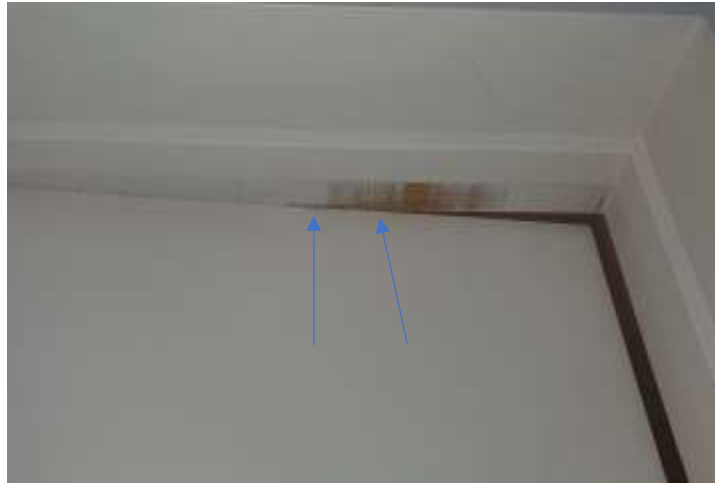
Dressing room door binding

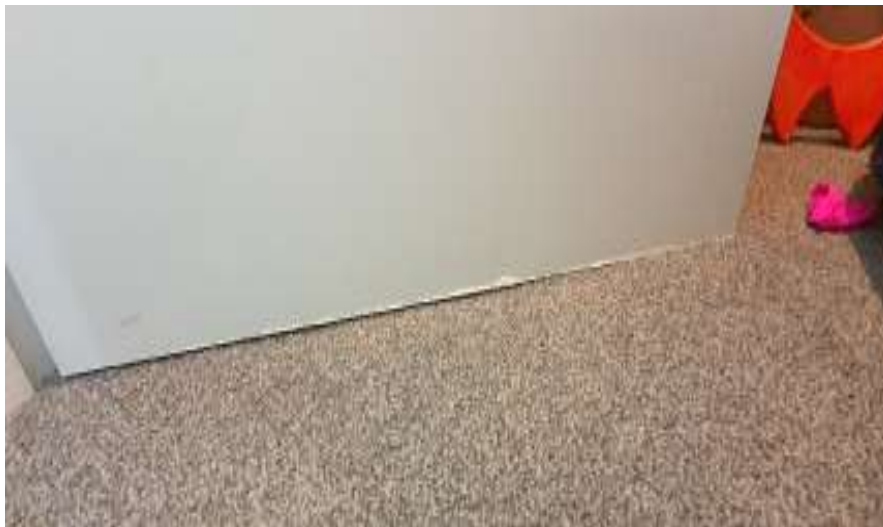
Dressing room door catching carpet

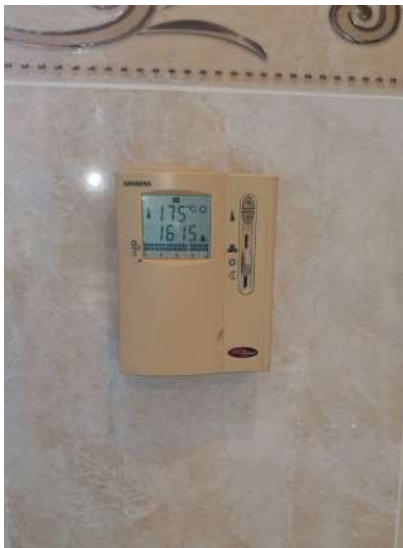
Underfloor heating system

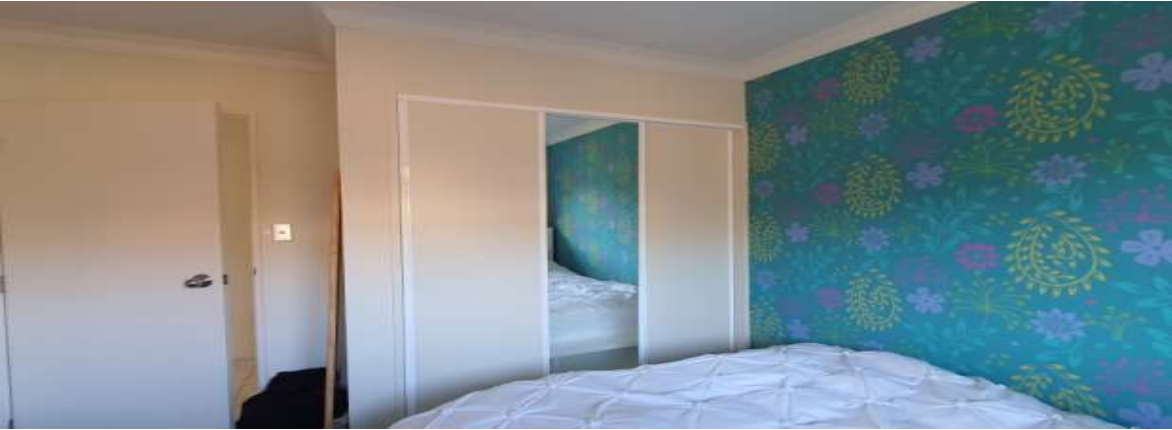
The bedroom door catching carpet

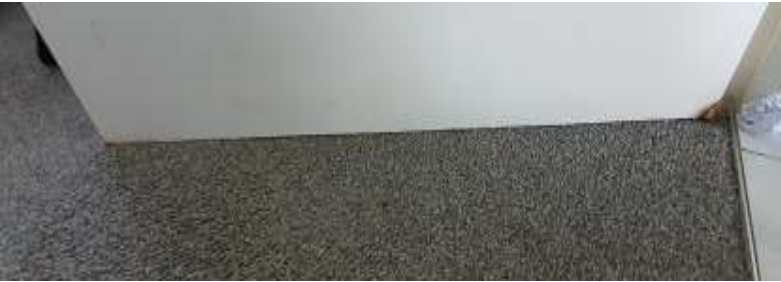
The bedroom door catching carpet

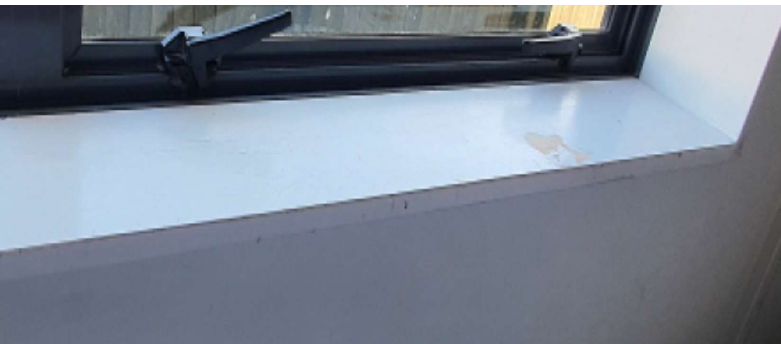
Paint to window sill to be completed

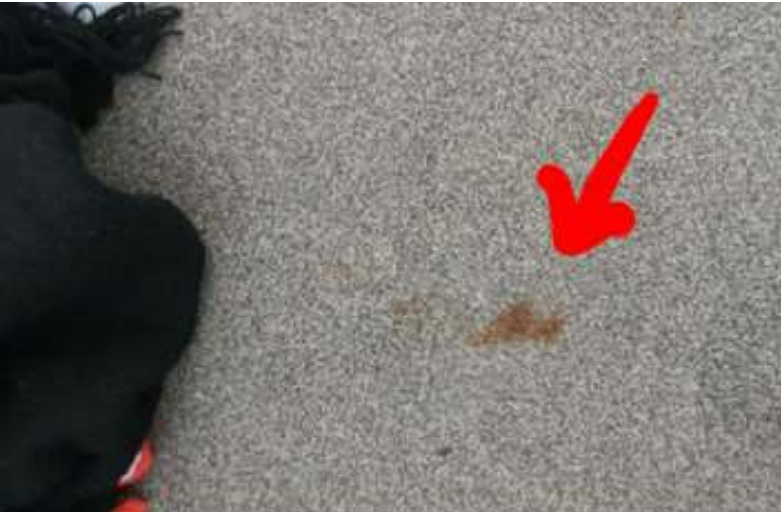
Mark on carpet floor

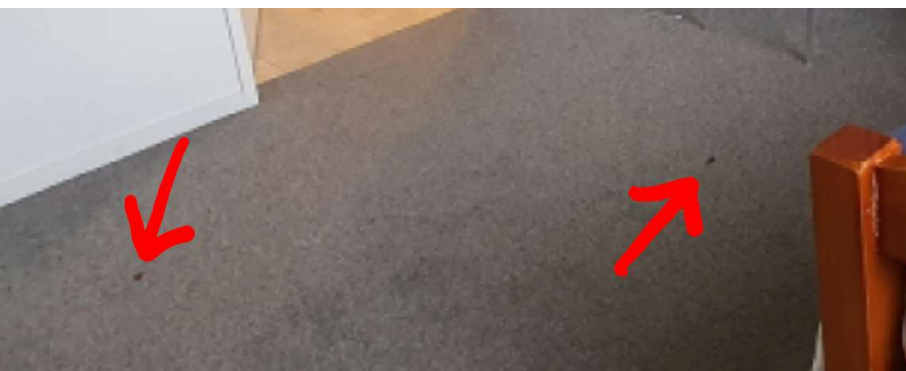
Marks on the carpet floor

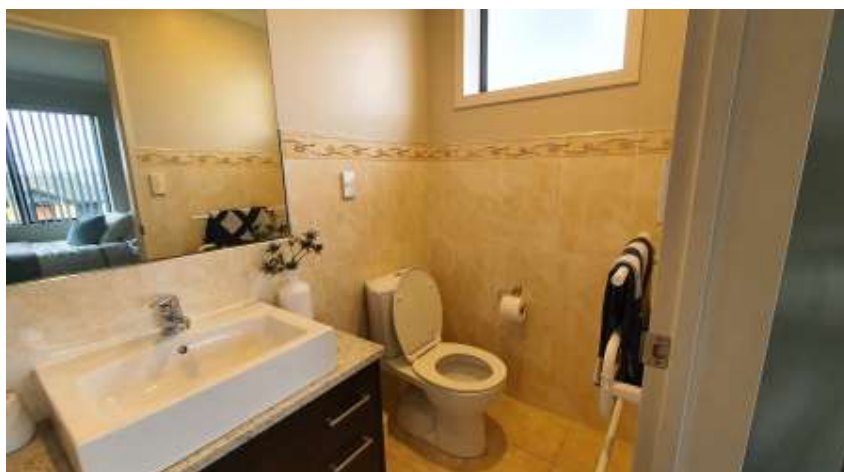
No leaks to shower cubicle

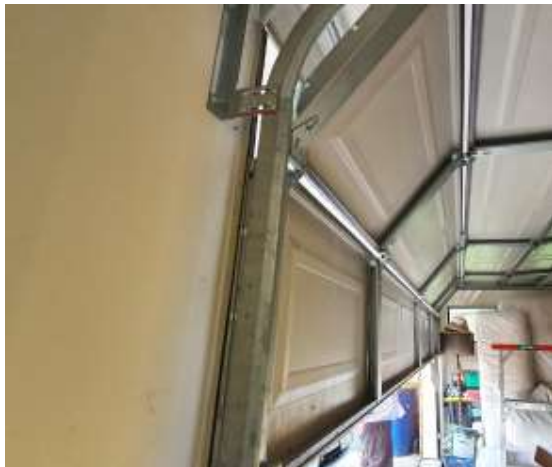
Garage door open and close smoothly.

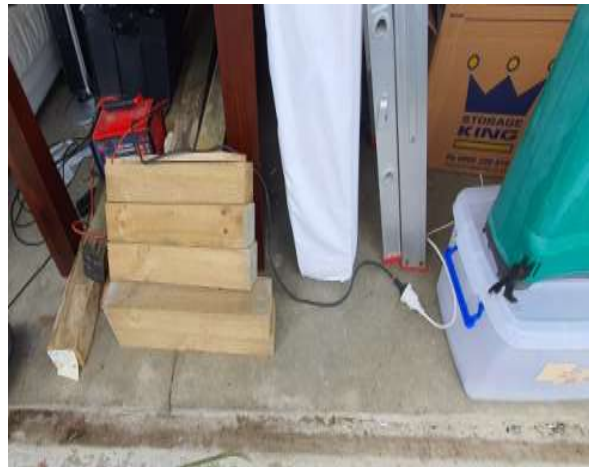
Concrete floor

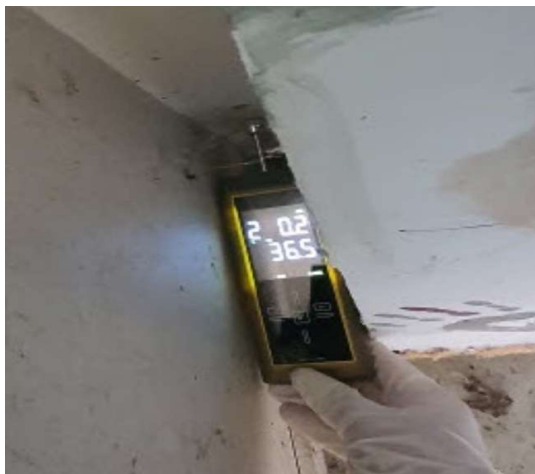
Moisture meter reading acceptable

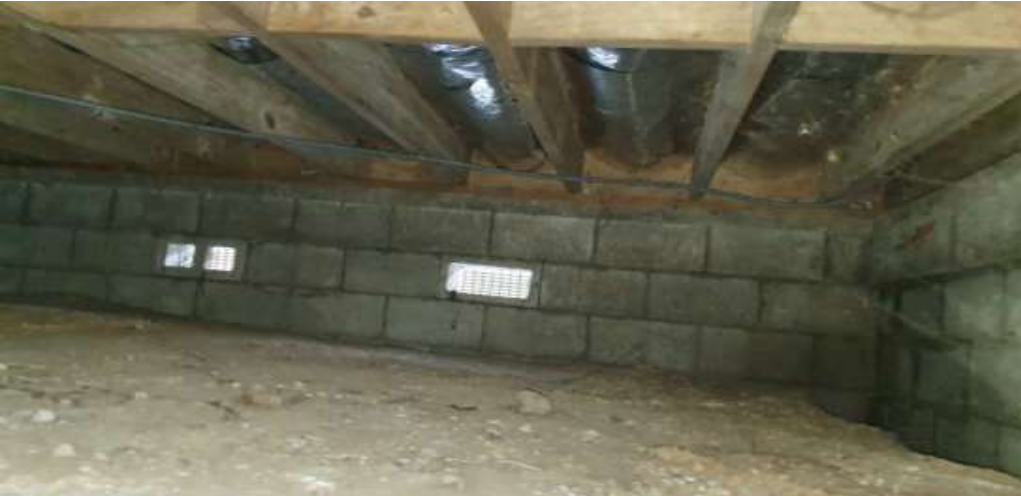
Sisilation to underside of floor. Sub floor dry

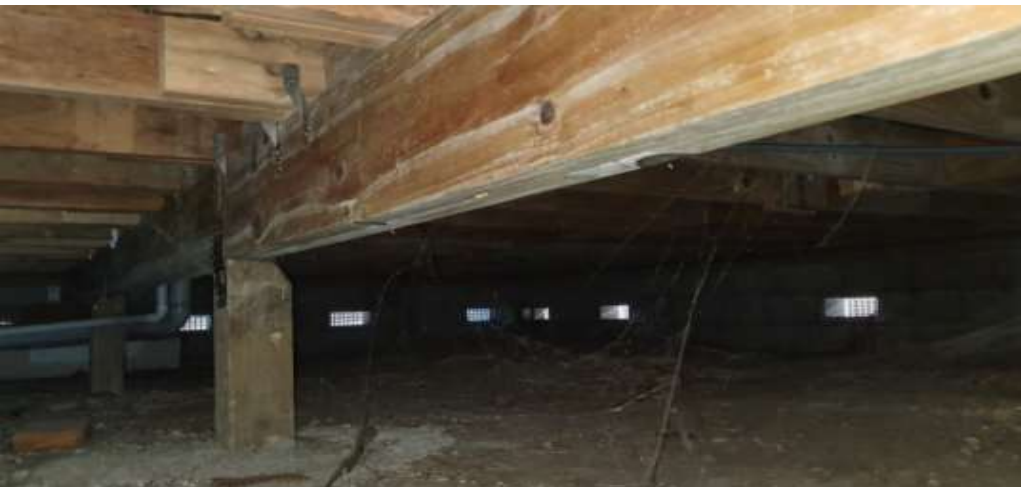
Timber piles fixed to floor beam. Floor joist fixed to floor beam

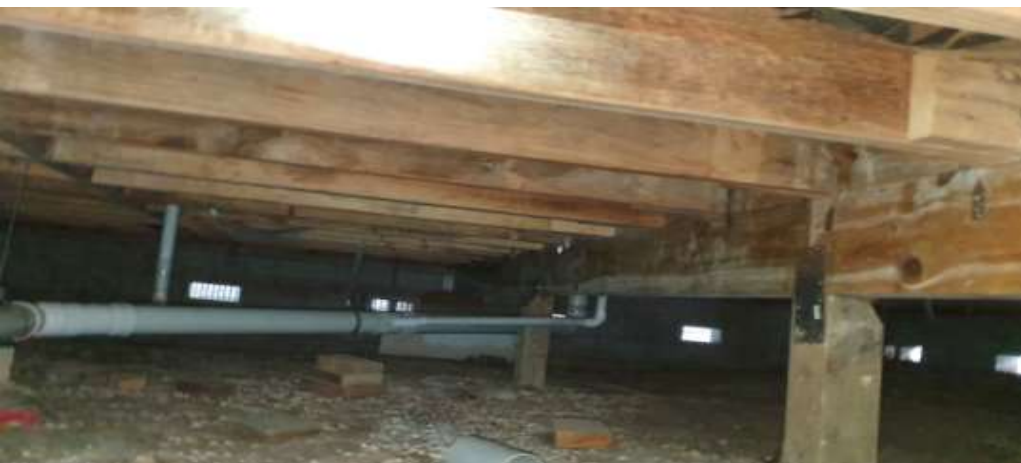
Plumbing piles securely fixed to underside of floor joists with hangers

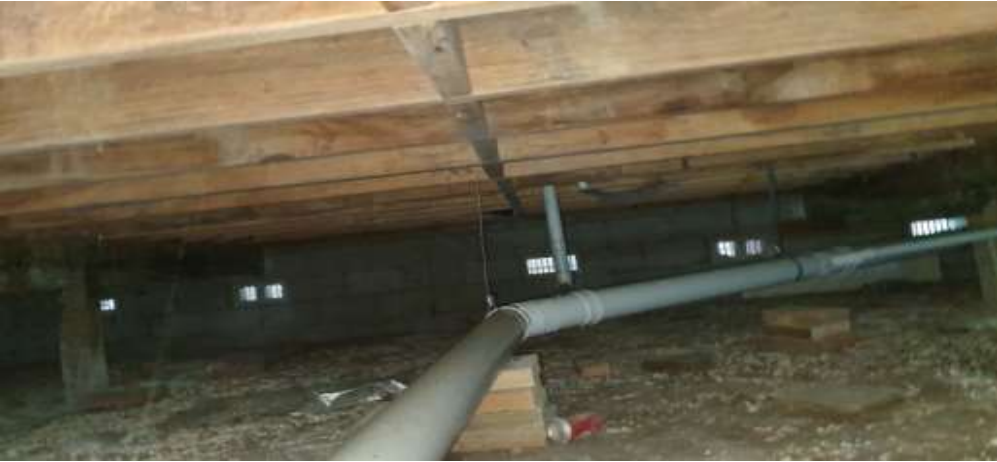
Plumbing pipes securely fixed to underside of floor joists with hangers

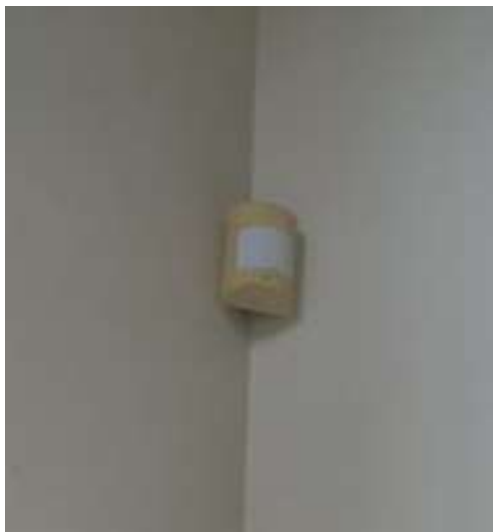
Alarm sensor not tested

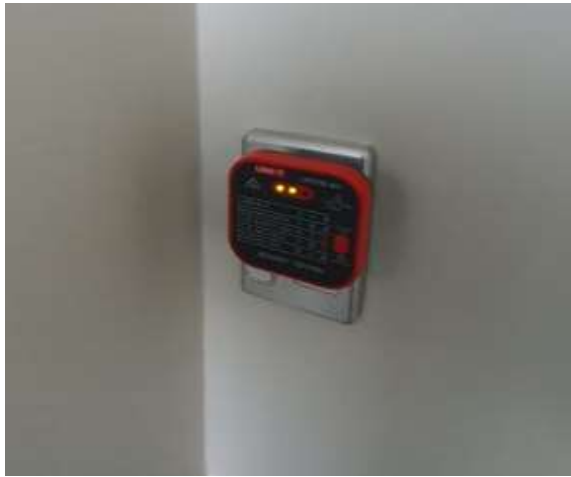
The electric power sockets need to be checked by an electrician as some of them tripped the earth leakage

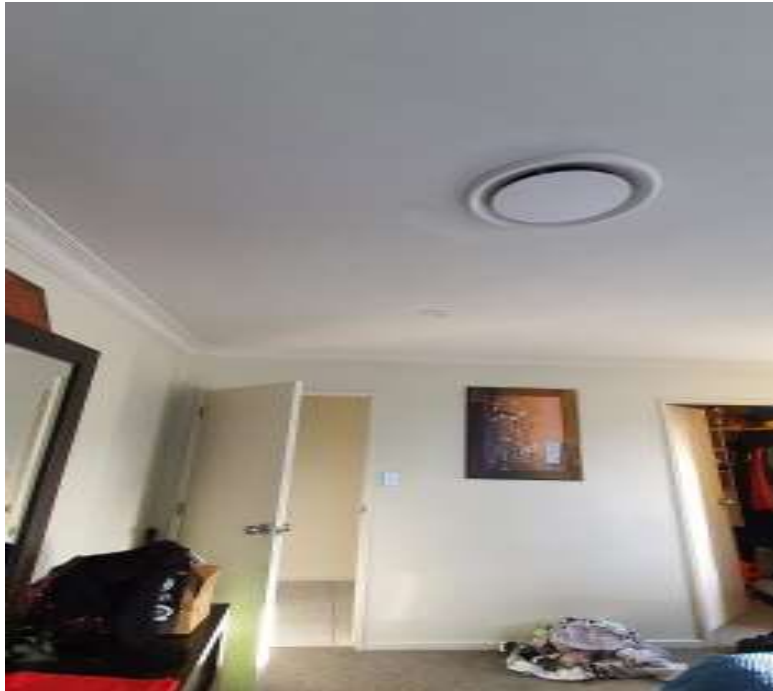
HRV System throughout the house  
No HRV System in the downstairs bedroom but heat pump installed.

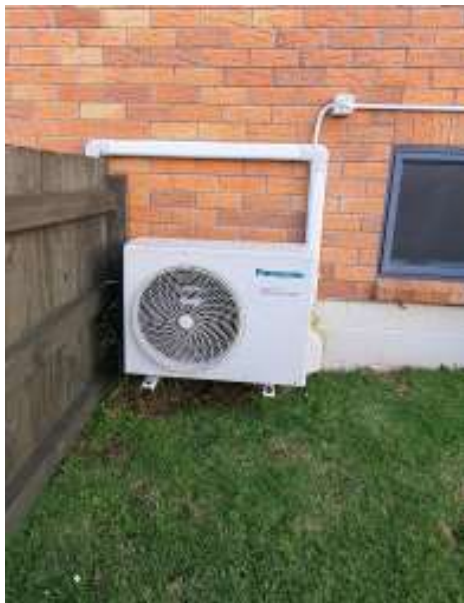
Heat pump wall mounted

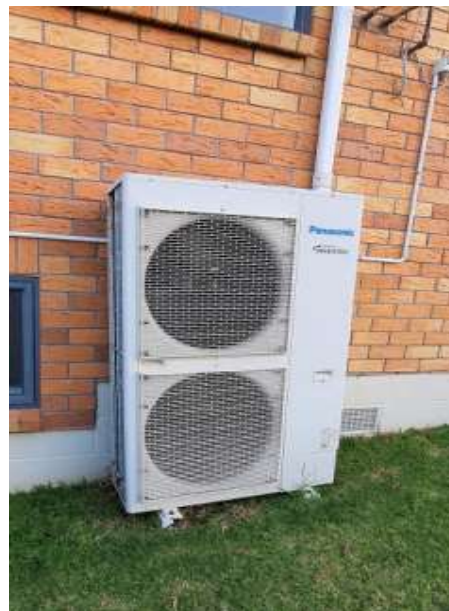
Heat pump on concrete base

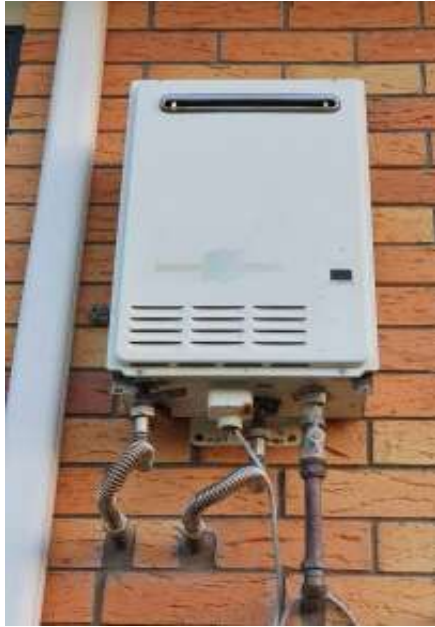
Gas water heater

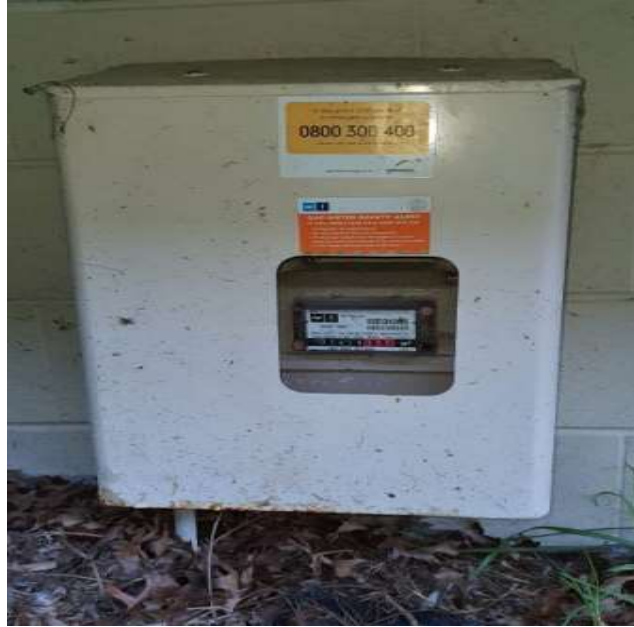
Gas meter to outside wall of garage
